# **Impact of Cracking beneath Solder Pads in Printed Board Laminate on Reliability of Solder Joints to Ceramic Ball Grid Array Packages**

**ESA-STM-267**

## Abstract

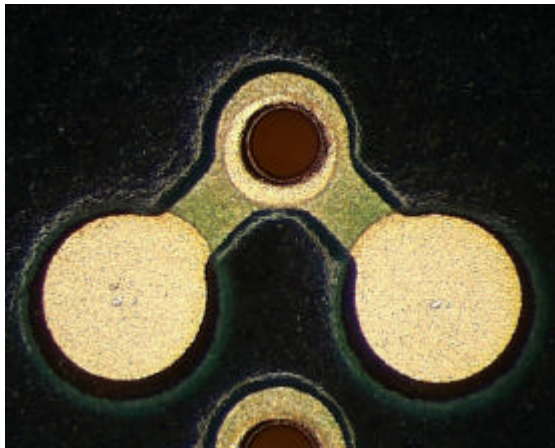
Figure 1. “Dogbone” design of connection between solder pad and via. Two solder pads are connected to the same via in this case

In the previous study, connections to the solder pads on the printed board were made on the upper surface of the board through a “dogbone” design (Figure 1). In order to facilitate rooting, connections are often made using a via-in-pad design. Figure 2 shows a polyimide-filled blind via-in-pad that has been capped with copper to achieve a flat solder pad. Cracking of the laminate beneath the solder pad will increase the stress on the connection between the solder pad and the copper barrel in the via hole. A case study of a thermally cycled Dimple BGA mounted on a printed board with via-in-pad connections, performed in the previous study, showed that this may result in cracking of the copper barrel (Figure 3). Laminate cracks may also form paths for current leakage in humid conditions.

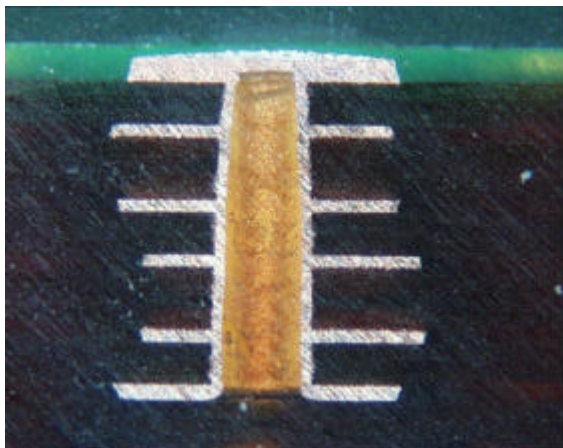
Figure 2. Cross-section of a polyimide-filled blind via-in pad capped with a flat copper layer

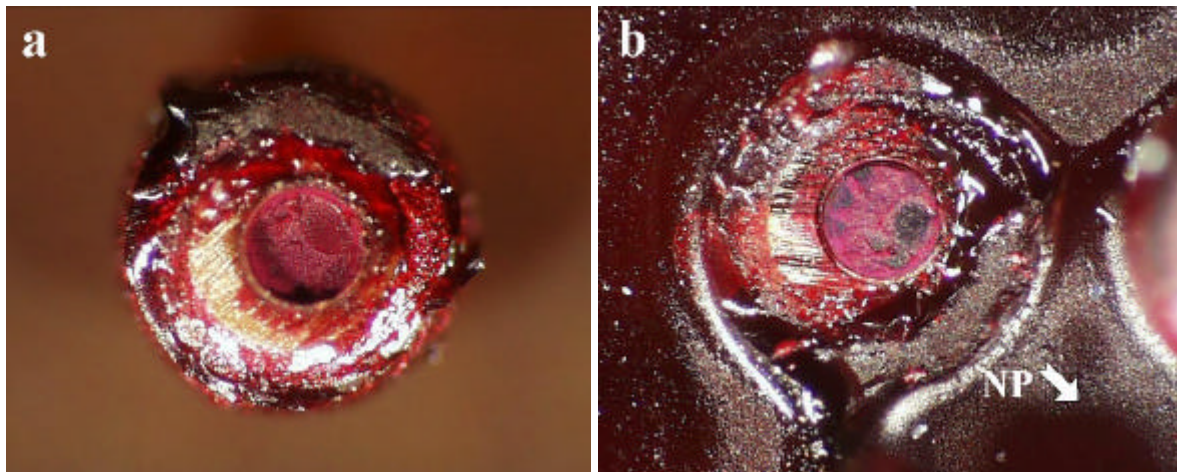
*Figure 3. Views showing the fracture between a pad and the board laminate for a corner solder joint to a Dimple BGA analysed using a red dye penetrant. View (a) shows the solder ball with the underside of the ripped off pad and view (b) shows the location on the PCB where the ball was attached*

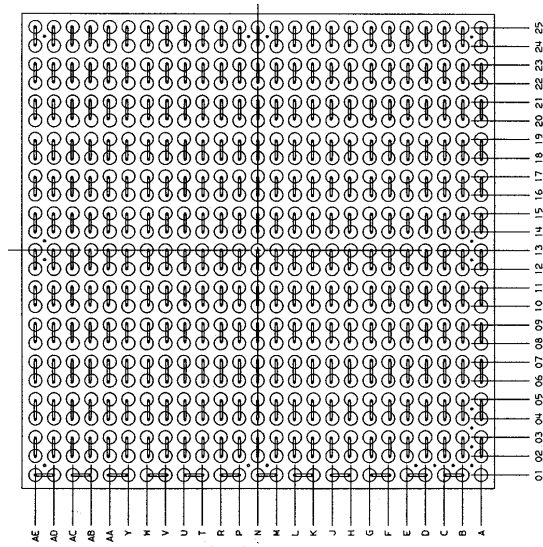
Figure 4. Package daisy chain (bottom view) and coordinates for ball numbering system

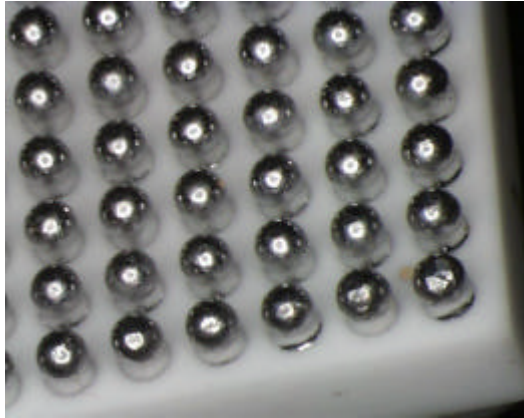
Figure 5. Photograph showing some of the balls on a ceramic BGA

The balls consisted of high-melt solder (10% Sn/90% Pb) and the ball diameter was 0.89 mm. They were soldered to the modules using eutectic solder. A corner of a package is shown in Figure 5.

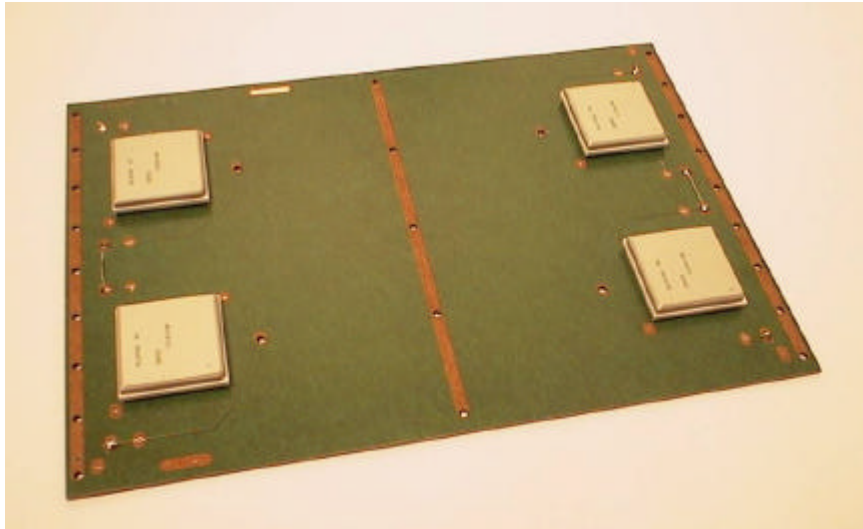
Figure 6. Test vehicle with dogbone design mounted with four CBGAs

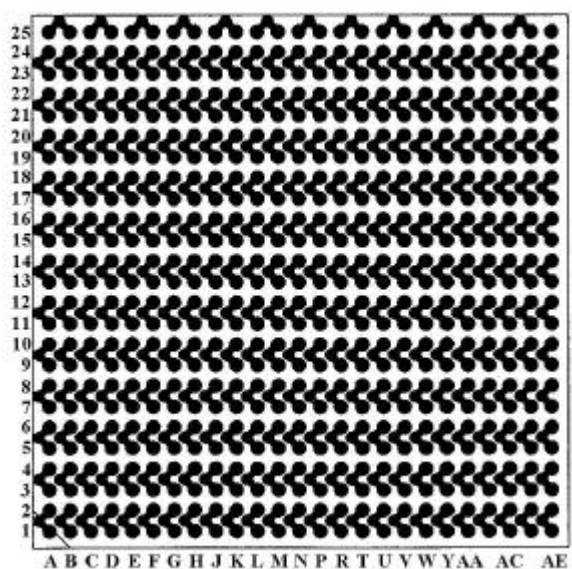
Figure 7. Footprint design with dogbone design for mounting of a CBGA package

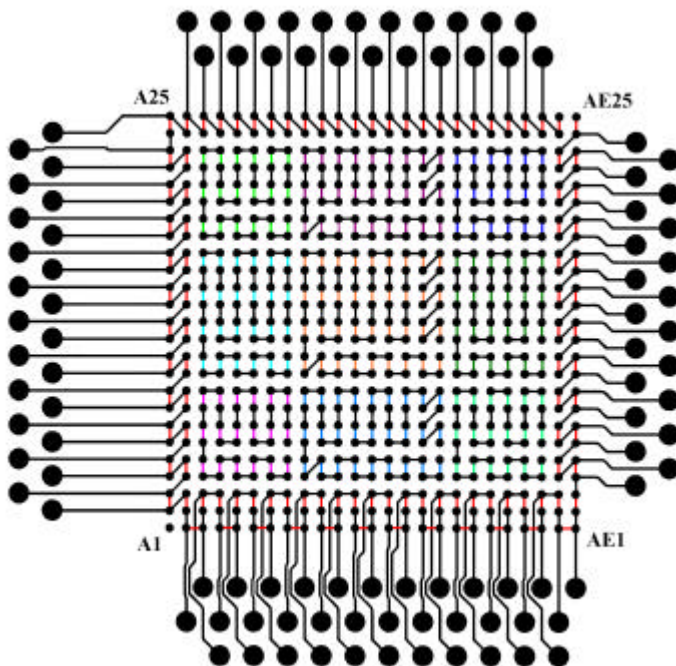
Figure 8. Footprint design on the board with via-in-pad design and daisy chain interconnections for a mounted component marked with various colours

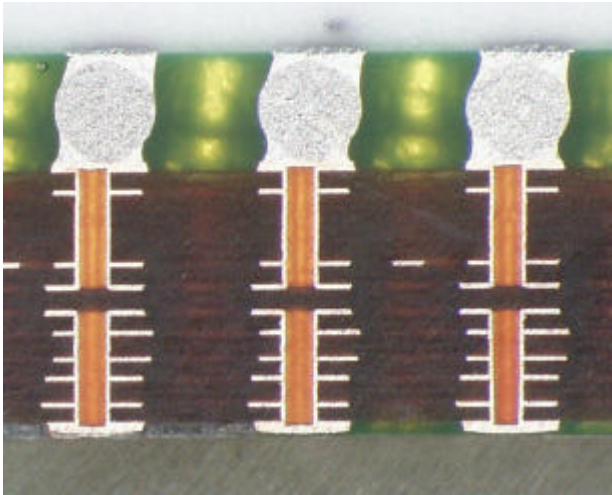
Figure 9. Cross-section of a board with via-in-pad design mounted with a CBGA

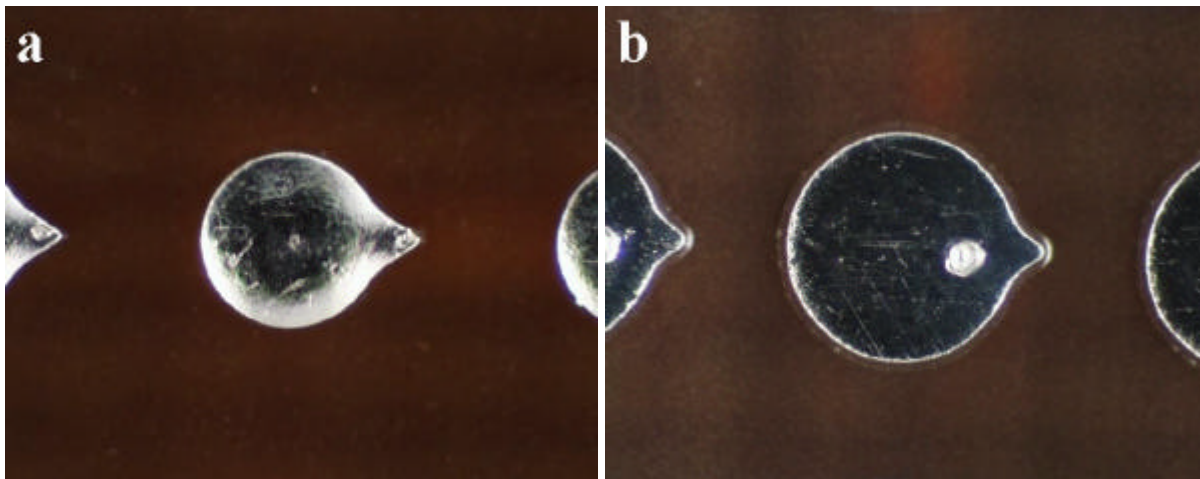
Figure 10. Photographs of solder pads on boards with via-in-pad design from Manufacturers X (a) and Y (b) taken with the same magnification. The marks on the solder pads are from electrical testing

Large differences in solder-pad form were observed for the boards with via-in-pad design supplied from the two board manufacturers. The solder pads on the boards from Manufacturer X had a diameter of 0.63 mm consistent with the nominal value, whereas they had a diameter of 0.80 mm on the boards from Manufacturer Y (Figure 10). Furthermore, the copper in the pads was thicker on the boards from Manufacturer X (about 100-150  $\mu\text{m}$  versus about 75  $\mu\text{m}$  for Manufacturer Y). The pads were also more uneven in thickness and flatness on the boards from Manufacturer X (Figure 11) although the flatness of most solder pads was better than for the one shown in Figure 11.

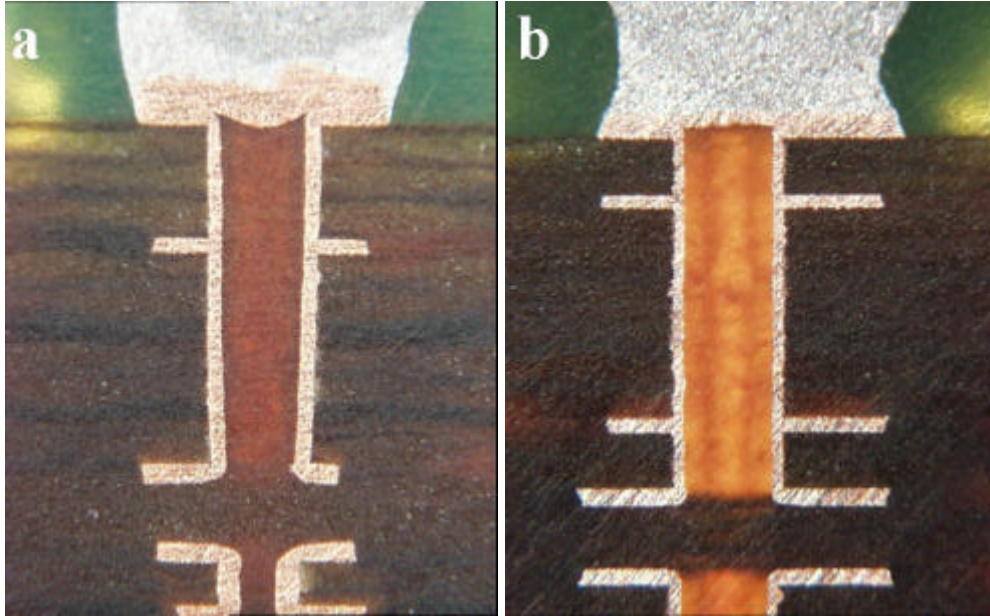
Figure 11. Cross-sections of solder pads and via-in-pads on printed boards from Manufacturer X (a) and Y (b)

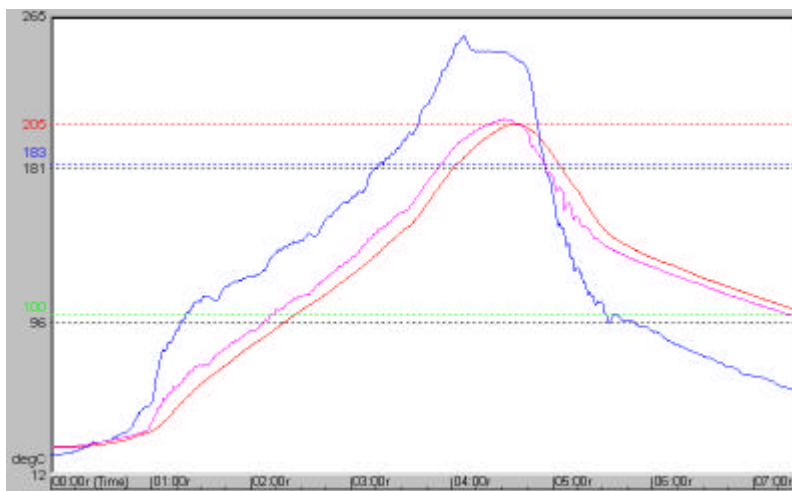
Figure 12. Convection-oven temperature profile used with low temperature peak, showing the temperature of the board, corner joint, and centre joint with temperature peaks of 255, 210, and 207°C, respectively

high peak temperature. The profiles used with low and high peak temperatures are shown in Figures 12 and 13, respectively. For the profile with low temperature peak, the peak temperatures of corner and centre joints were determined to be 210 and 207°C, respectively, whereas for the profile with high temperature peak they were determined to be 227 and 238°C, respectively. Normally, the temperature for corner joints is higher than for centre joints and the form of the curve for the corner joint in Figure 13 indicates that there may have been some trouble with its thermocouple. Thus, the peak temperature of the corner joint was probably just above 240°C in the profile with high peak temperature. The minimum and maximum peak temperatures recommended by IBM are 210 and 235°C, respectively. A higher peak temperature than 235°C is reported to result in dissolution of lead from the high-melt ball into the eutectic solder causing an increase in melting temperature. That will make repair more difficult but it should not affect fatigue life [3].

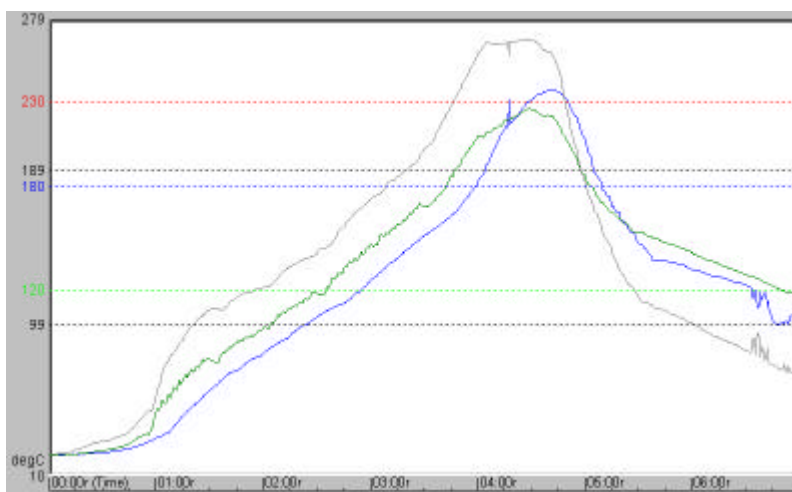
Figure 13. Convection-oven temperature profile used with high temperature peak, showing the temperature of the board, corner joint, and centre joint with temperature peaks of 267, 227, and 238°C, respectively

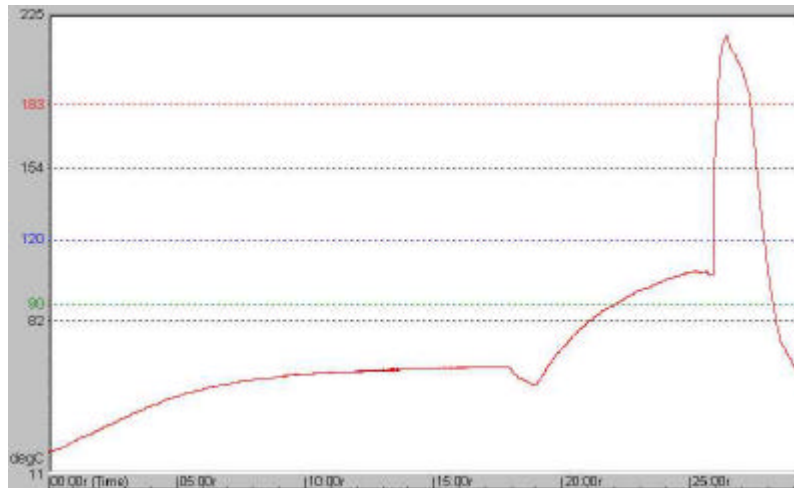
*Figure 14. Typical temperature profile achieved for vapour-phase soldering*

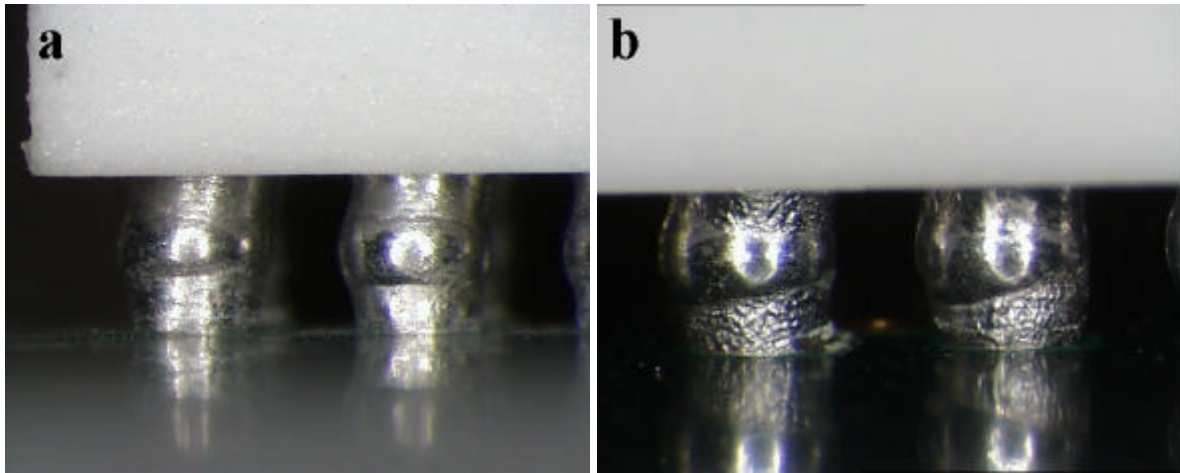
*Figure 15. Appearances of solder joints after soldering using the profiles with low (a) and high (b) peak temperature*

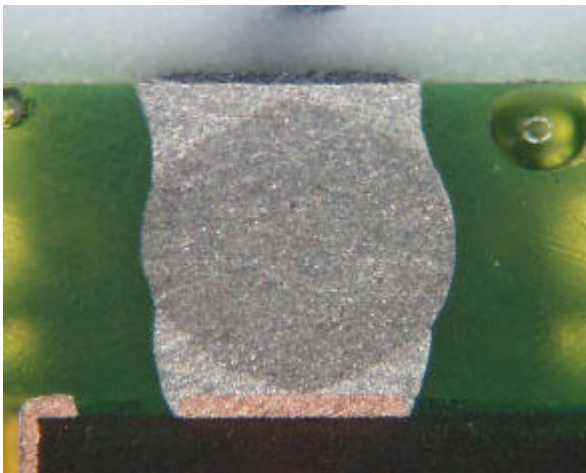
*Figure 16. Cross-section of centre solder joint (M14) soldered using the temperature profile with low peak temperature*

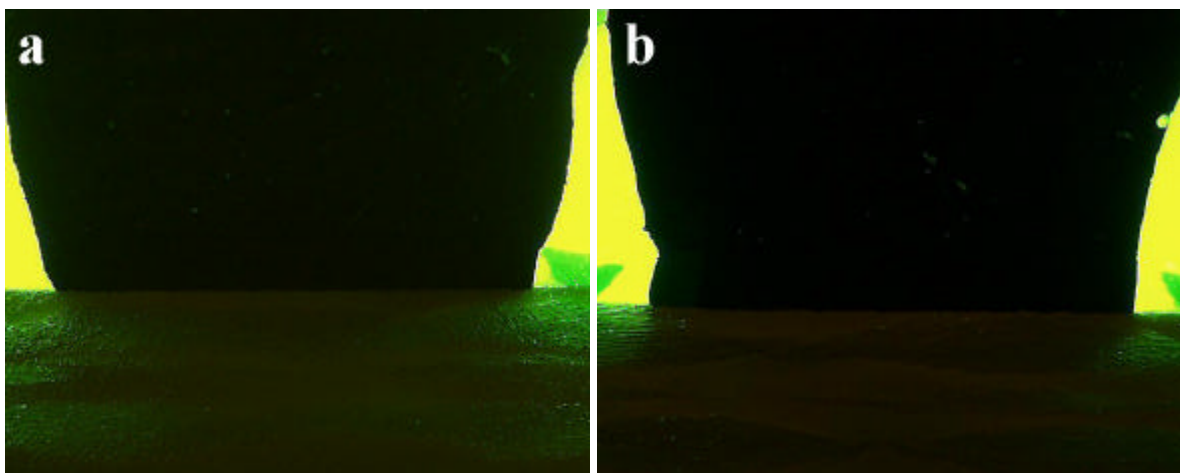
*Figure 17. Cross-sections of corner solder joints showing the laminate beneath the solder pads on boards soldered using low (a) and high (b) peak temperature examined with UV light*

The assemblies soldered using convection soldering were examined for cracks in the laminate beneath solder pads after soldering. No cracks could be found, neither on the assemblies soldered using the low peak temperature nor on the assemblies soldered using the high peak temperature (Figure 17).

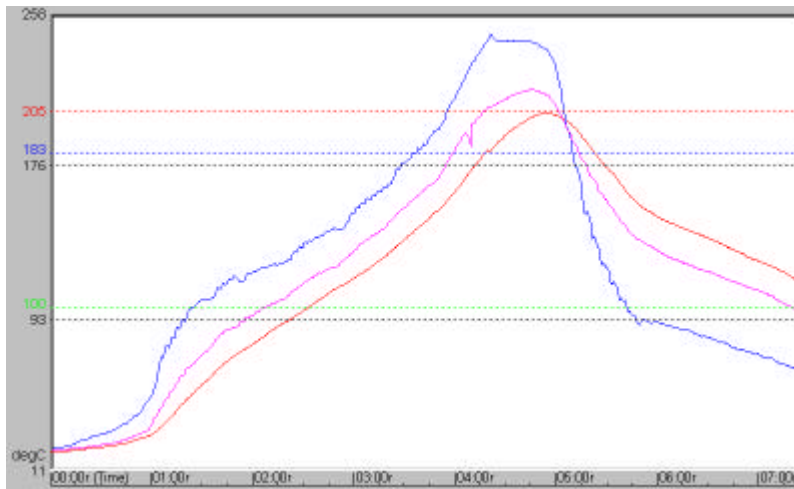
*Figure 18. Soldering profile used for the boards with via-in-pad design showing the temperature of the board, corner joint, and centre joint with temperature peaks of 248, 218, and 206°C, respectively*

The soldering profile used for soldering the boards with via-in-pad design was similar to the one used with low peak temperature for the boards with dogbone design, but with somewhat higher peak temperature for corner joints (Figure 18). A larger deviation in peak temperature between corner and centre joints was observed for the boards with via-in-pad design compared to the board with dogbone design. This larger deviation is probably due to the larger number of inner layers in the boards with via-in-pad design, i.e. they have more copper in the board laminate.

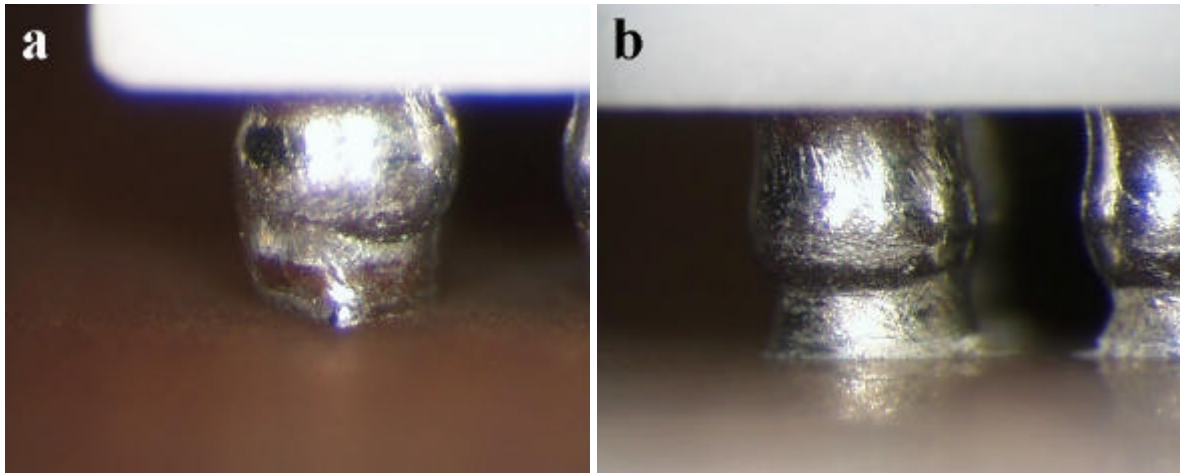
*Figure 19. Appearances of solder joints on assemblies soldered using printed boards with via-in-pad design from Manufacturers X (a) and Y (b)*

The appearances and cross-sections of typical solder joints are shown in Figures 19 and 20, respectively. The solder joints on the boards from Manufacturer X had an appearance similar to the solder joints on the boards with dogbone design, whereas a different appearance was observed for the solder joints on the boards from Manufacturer Y. Due to the larger pad diameter on these latter boards, the eutectic solder fillet between the board and the high-melt ball had a concave surface and not a convex surface as on the other boards. That is, whereas the smallest diameter of the solder fillets on the boards produced by Manufacturer Y was between the solder pads and the high-melt balls, it was at the base towards the printed board on the boards from Manufacturer X.

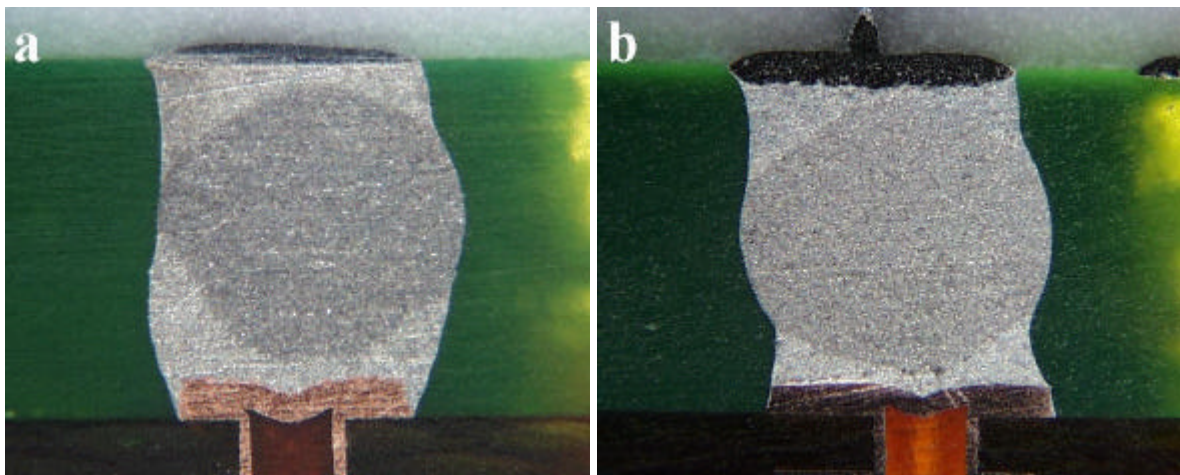
*Figure 20. Cross-sections of solder joints on assemblies soldered using printed boards with via-in-pad design from Manufacturers X (a) and Y (b)*

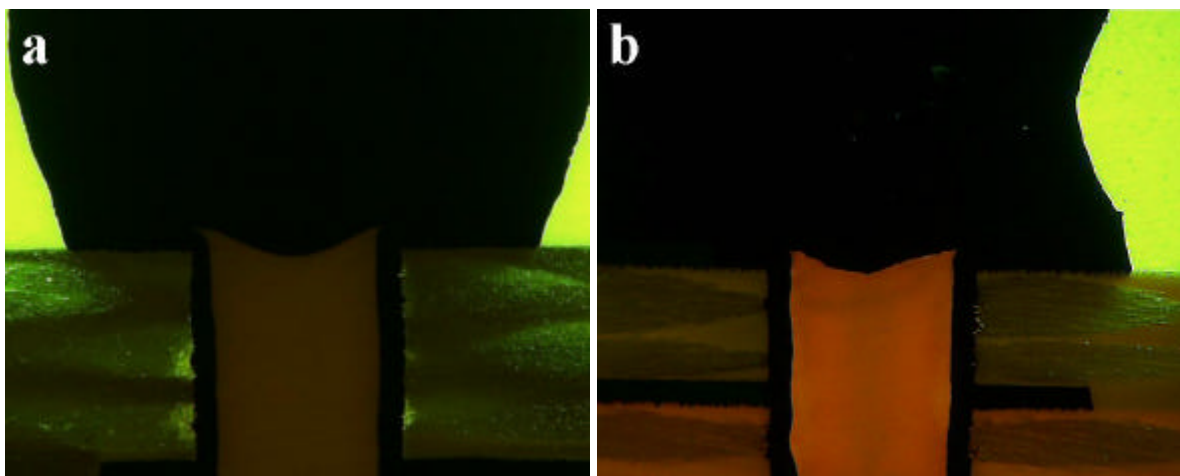
*Figure 21. Cross-sections of corner solder joints showing the laminate beneath the solder pads on boards with via-in-pad design from Manufacturers X (a) and Y (b) examined with UV light*

As for the assemblies manufactured with dogbone design, no cracks were found in the laminate beneath the solder pads on the assemblies with via-in-pad design after soldering (Figure 21).

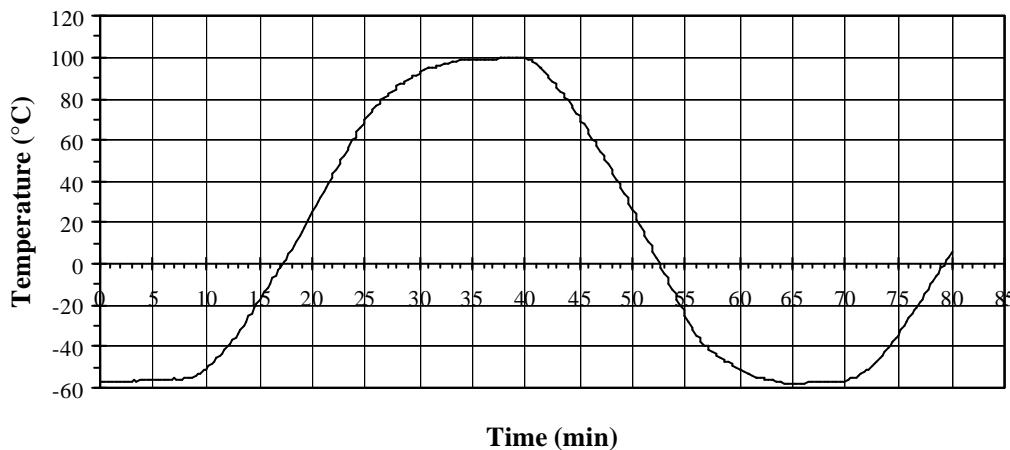
Figure 22. Temperature profile measured for a corner lead to a CBGA during the thermal cycling test

Temperature cycling was performed as per ECSS-Q-70-08A, Section 13.2 [5]. An air-circulating oven, Heraeus HT 7015-10/S, was used for the test. The temperature was cycled between -55 and +100°C with a temperature ramp of 10°C/min and a soak time of 15 min at each temperature extreme. The actual temperature profile measured for a corner lead to a package is shown in Figure 22.

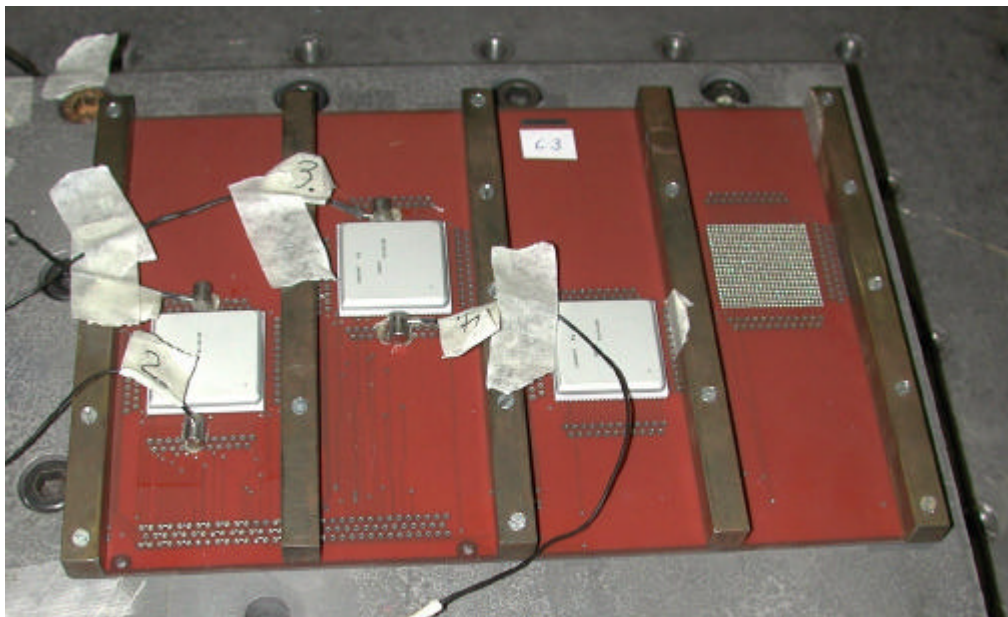
Figure 23. View of a test board with via-in-pad design mounted on the vibration exciter

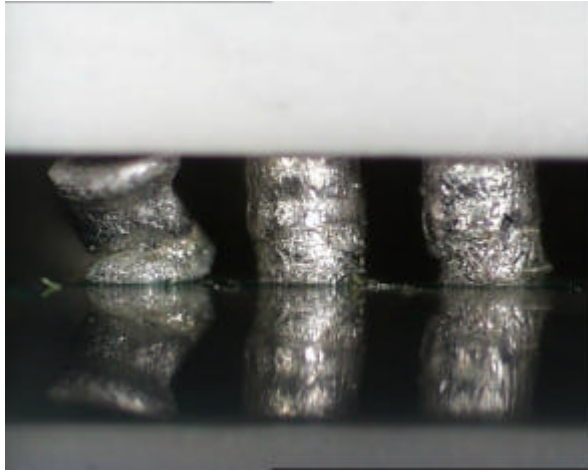
Figure 24. View showing two solder joints to the right that had failed after 100 thermal cycles. The total numbers of performed cycles are 500

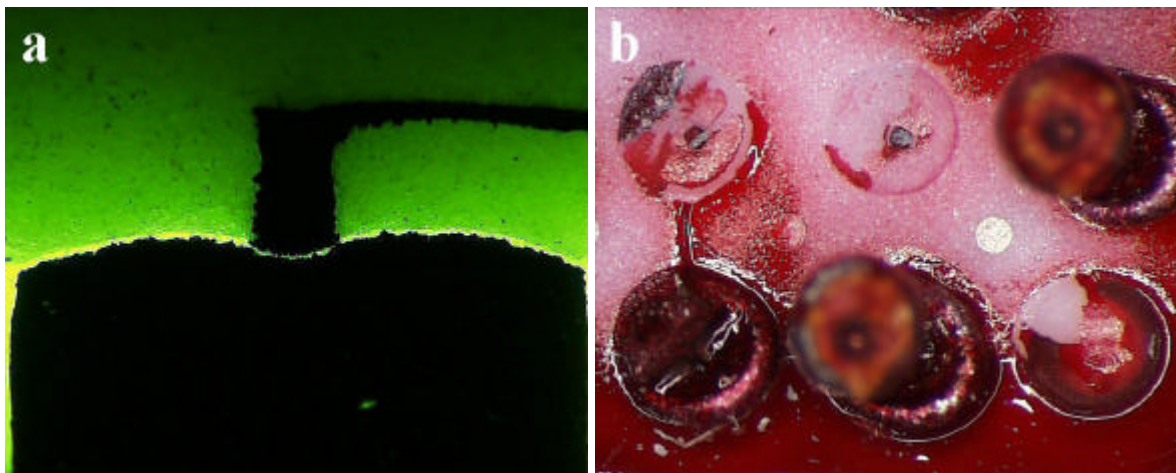
Figure 25. Detachment of solder pads on components analysed with UV light (a) and dye penetrant (b)

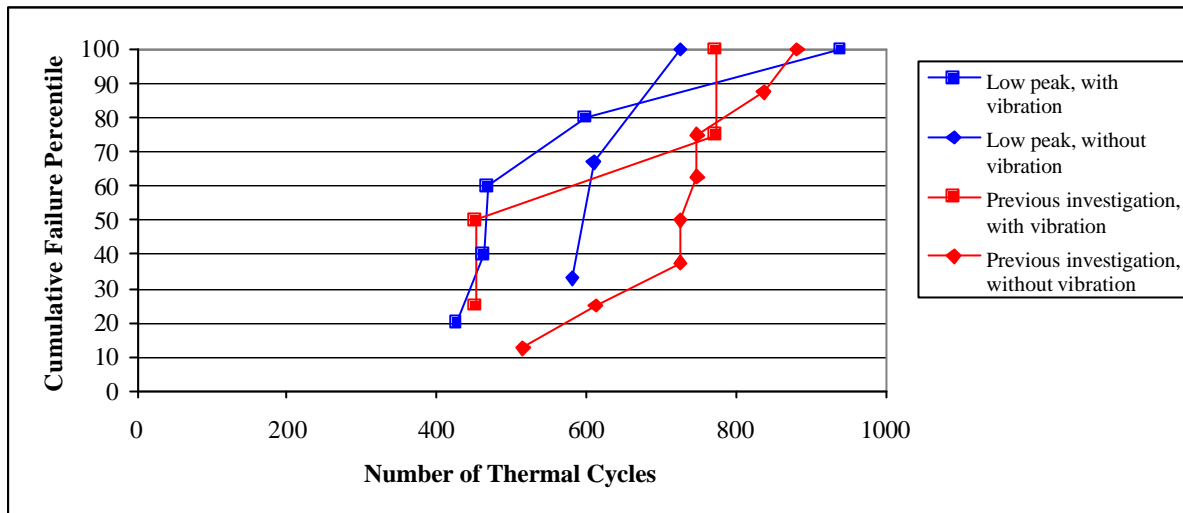
Figure 26. Cumulative cycles-to-failure of CBGAs mounted on boards with dogbone design, soldered with low peak temperature. For comparison, the corresponding results from the previous investigation are also given

The results from testing of the assemblies soldered using a profile with low peak temperature are presented in Figure 26. A comparison is made with the results obtained in the previous investigation. As can be seen in Figure 26, the results obtained in the two investigations are similar, although the number of components tested to failure in this investigation is too low to draw any definite conclusions. Maybe the fatigue life was somewhat shorter for the assemblies tested in this investigation. Also, the results indicate that the addition of vibration exposure after 100 cycles caused a decreased fatigue life of 10-30%. However, there are irregularities in the curves for the CBGAs that have been exposed to vibration, and the last CBGA to fail in this investigation was, in fact, a CBGA that had been exposed to vibration.

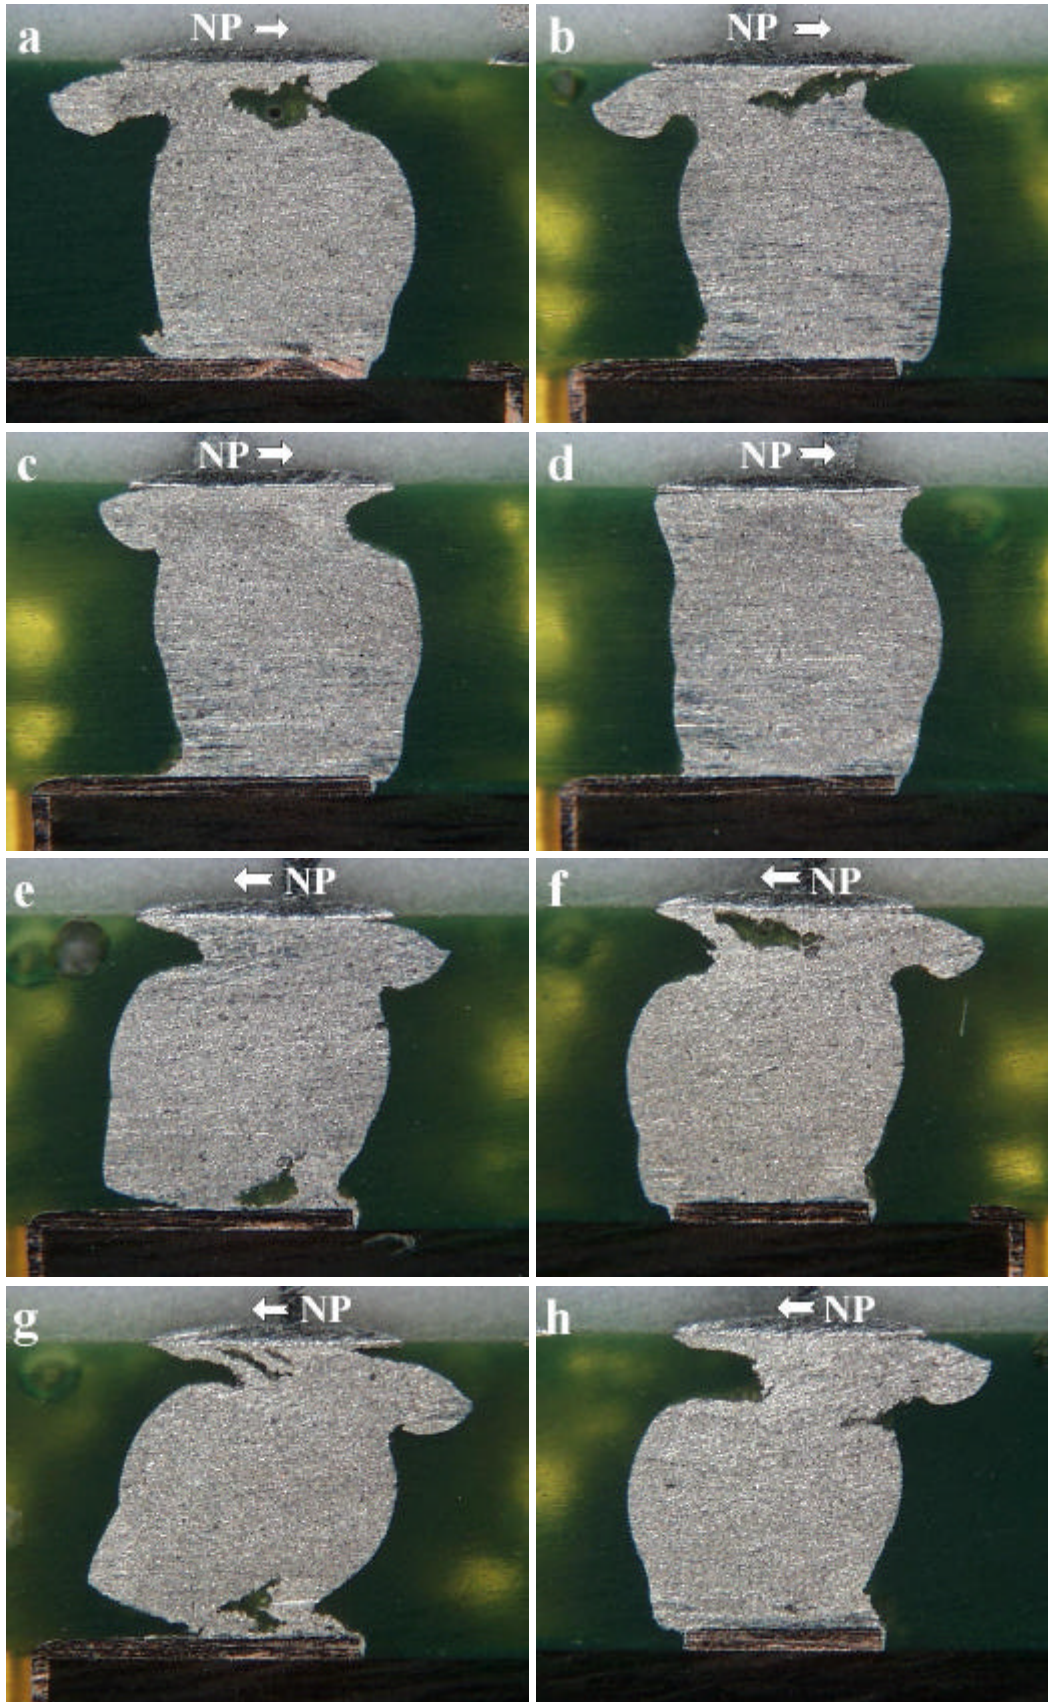
*Figure 27. Cross-sections of joints to a CBGA, soldered using the low peak temperature and exposed to 500 thermal cycles. Views are taken at Positions A1 (a), D4 (b), F6 (c), H8 (d), AB22 (e), AC23 (f), AD24 (g), and AE25 (h). The arrows show the direction to the Neutral Point (NP) at the centre of the CBGA*

Figure 27 shows cross-sections of solder joints along the diagonal from Solder Joints A1 to AE25 for a CBGA that has been exposed to 500 thermal cycles but without vibration. The extent of deformation and cracking of the solder joints were identical to the results obtained in the previous investigation. When going from Solder Joint A1 towards the centre of the package, cracking and deformation of the solder joints are extensive for the first four joints and then decrease and are only just visible when reaching Solder Joint H8. The deformation and cracking are mainly located to the package side of the solder joints. The results are similar for Solder Joints AE25 and AC23 in the opposite corner of the package but quite different for Solder Joints AB24 and AD22. For these two latter solder joints, deformation and cracking have occurred both near the package and board sides of the solder joints, with the largest damage near the board side where the solder joints are almost completely cracked. When examining the board laminate under the solder pads using UV light, relatively large cracks were found in the laminate beneath the four outermost solder joints in the respective corner except for Solder Joints AB24 and AD22 (Figure 28). Small cracks in the laminate could be found beneath many solder pads five to ten solder joints from a corner. The cracks initiate on the inward side of the solder joints (the side towards the centre of the package). What differentiates Solder Joints AB24 and AD22 from the others is that the conductors to the interconnected via holes for these solder joints are located where the cracks initiate. Obviously, a conductor located there prevents a crack from initiating in the laminate.

Figure 30 shows cross-sections of solder joints to a CBGA that had been exposed to vibration after 100 thermal cycles and then to an additional 400 thermal cycles. A comparison with the cross-sections shown in Figure 27 indicates that the addition of vibration caused somewhat less deformation of the solder joints to occur during thermal cycling. An exception is Solder Joint AD24 for which cracking was still severe against the board pad. Since only one vibration-tested and one non-vibration tested component have been cross-sectioned, the observed difference is uncertain but a visual examination of the outer solder joints to other components, using an optical microscope, indicated that the difference in deformation is consistent for all tested components.

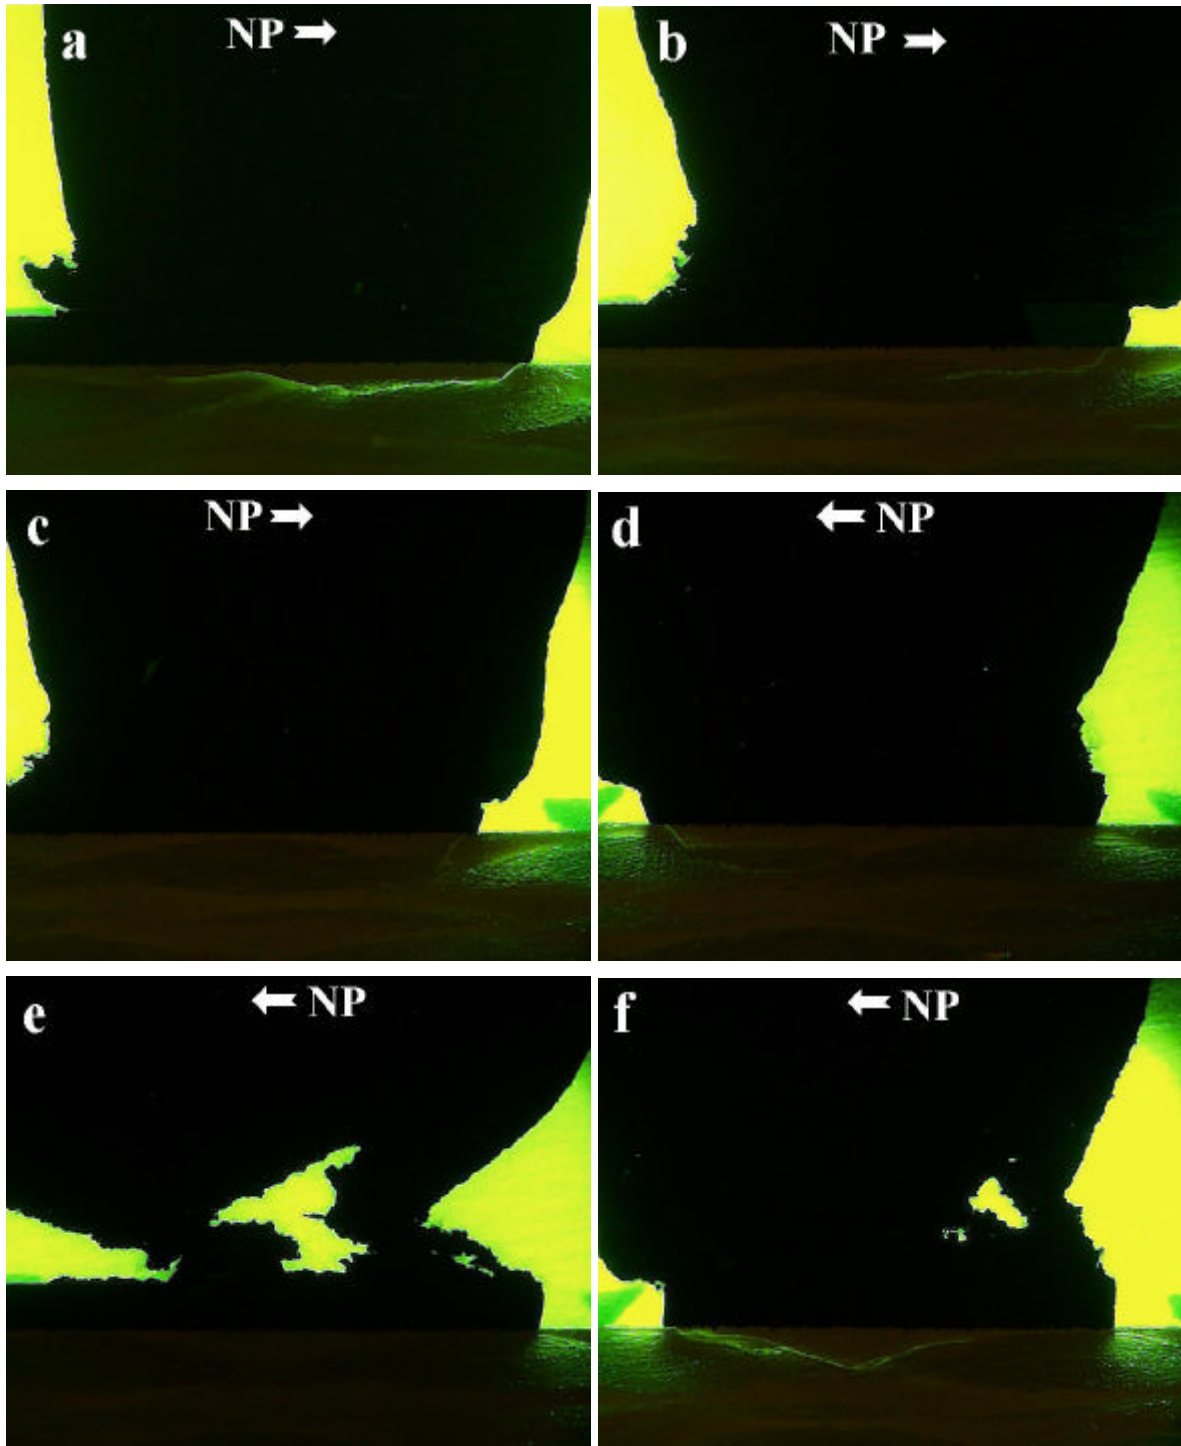
Figure 28. Cracks in the laminate beneath the solder pads to a CBGA soldered using the low peak temperature and exposed to 500 thermal cycles. Views are taken at Positions A1 (a), D4 (b), F6 (c), AC23 (d), AD24 (e), and AE25 (f)

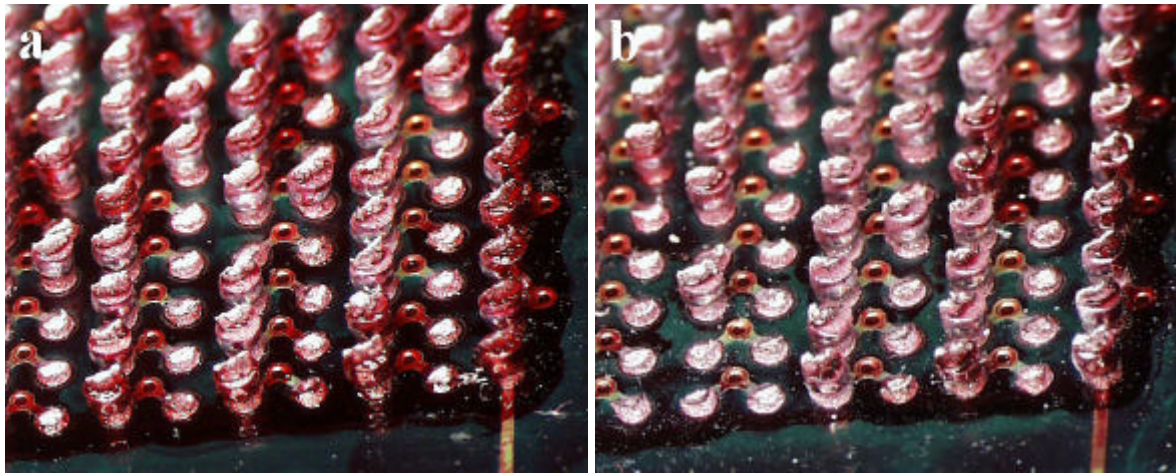
*Figure 29. Board views showing locations of cracks in the solder joints after 1000 cycles, analysed using a dye penetrant, for a CBGA that has not been exposed to vibration (a) and a CBGA that has been exposed to vibration (b)*

locations were solder joints failed first, i.e. the solder joints that had board pads connected inwards to vias, for which the solder balls remained on the CBGA (Figure 29).

Cracks were also found in the laminate beneath solder pads for the CBGA that had been exposed to vibration (Figure 31) but the extent of cracking did not show any discernible difference compared to the CBGA that had not been exposed to vibration. Nor did the extent of solder joint cracking and the locations of fractures analysed using the dye penetrant method show any discernible difference (Figure 29b).

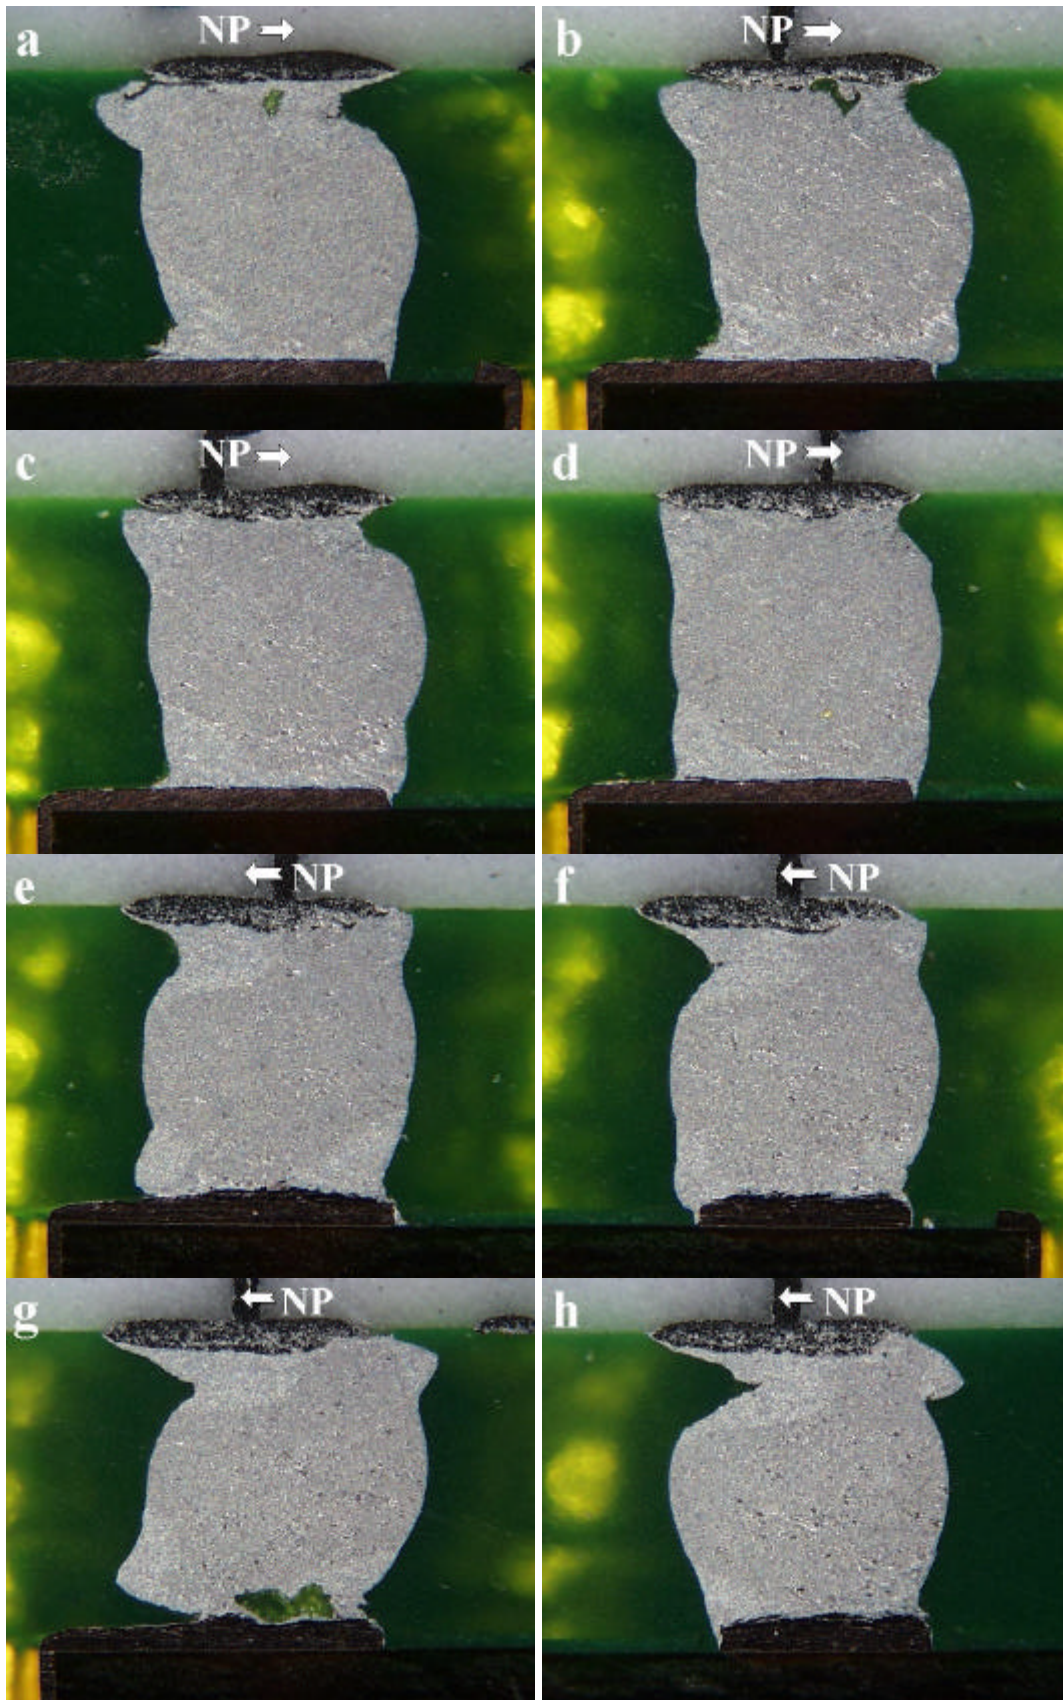
Figure 30. Cross-sections of solder joints to a CBGA soldered using the low peak temperature and exposed to vibration exposure and 500 thermal cycles. Views are taken at Positions A1 (a), D4 (b), F6 (c), H8 (d), AB22 (e), AC23 (f), AD24 (g), and AE25 (h)

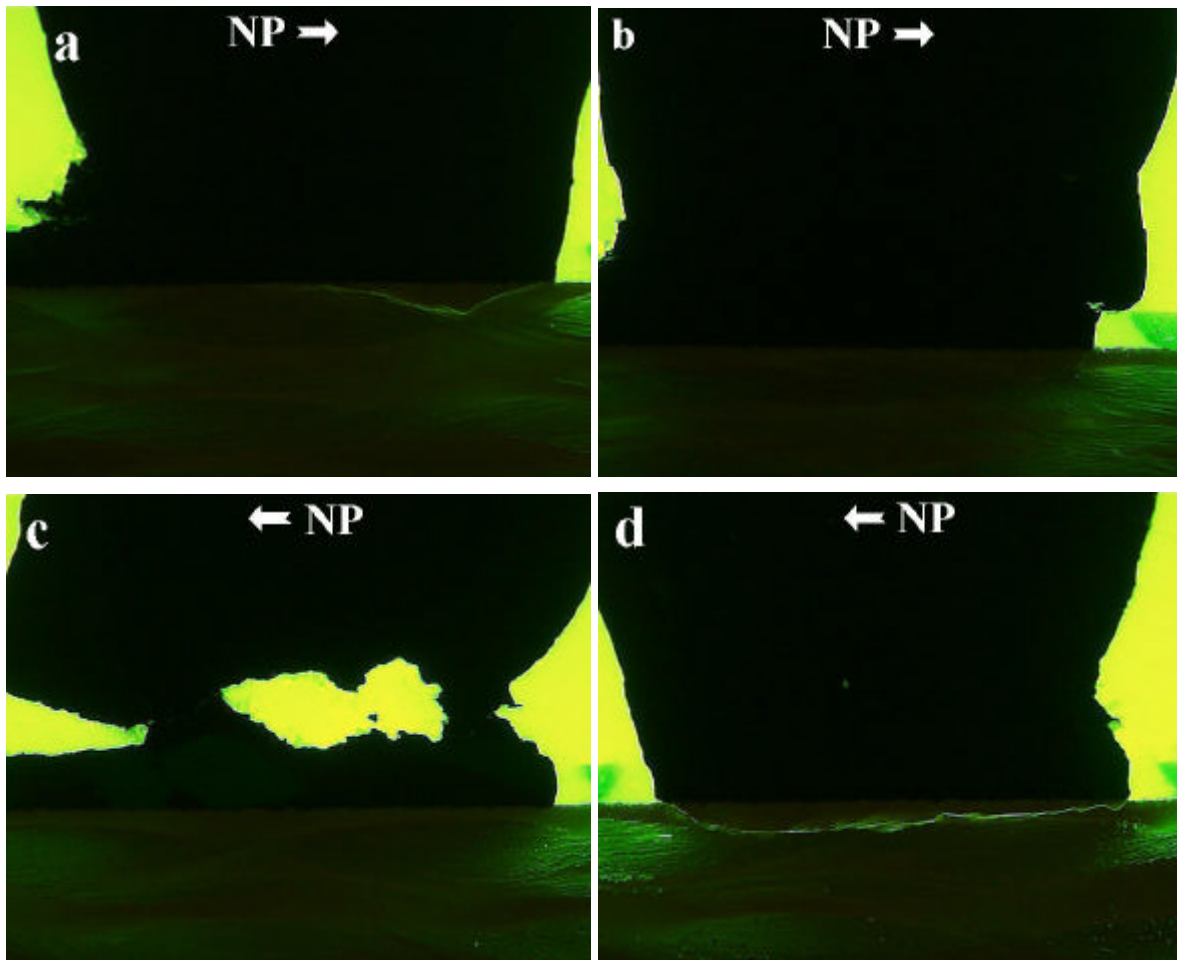
*Figure 31. Cracks in the laminate beneath the solder pads to a CBGA soldered using the low peak temperature and exposed to vibration exposure and 500 thermal cycles. Views are taken at Positions A1 (a), D4 (b), AD24 (c), and AE25 (d)*
