# **Impact of Cracking beneath Solder Pads in Printed Board Laminate on Reliability of Solder Joints to Ceramic Ball Grid Array Packages**

**ESA-STM-267**

## Abstract

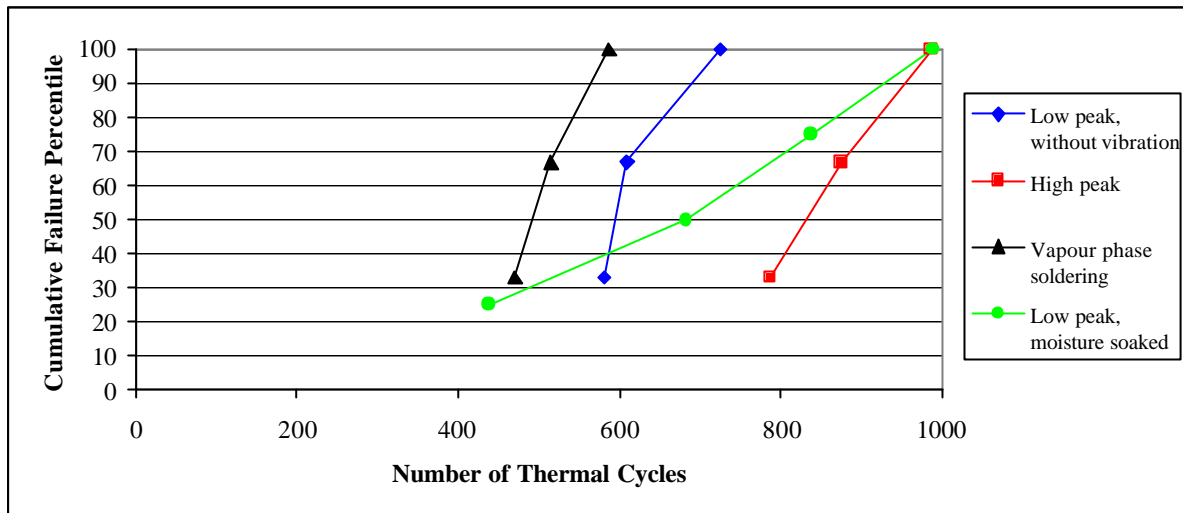
Figure 32. Cumulative cycles-to-failure of CBGAs mounted on boards with dogbone design soldered using various temperature profiles. The assembled CBGAs have been exposed to thermal cycling only

Figure 32 presents the results from testing of the assemblies with dogbone design that had been soldered using high peak temperature, vapour phase soldering, and moisture-soaked printed boards. Compared to assemblies soldered using low peak temperature, the solder joints to the CBGAs on the assemblies soldered using the profile with high peak temperature had about 40% longer fatigue life, whereas the vapour phase soldered CBGAs had about 20% shorter fatigue life. The results for the CBGAs on the moisture-soaked printed boards differed considerably. Whereas the slopes of the curves were about the same for all other cases, it was significantly lower for the moisture soaked-assemblies. In fact, the first failure, like the last, occurred for CBGAs mounted on the moisture-soaked boards.

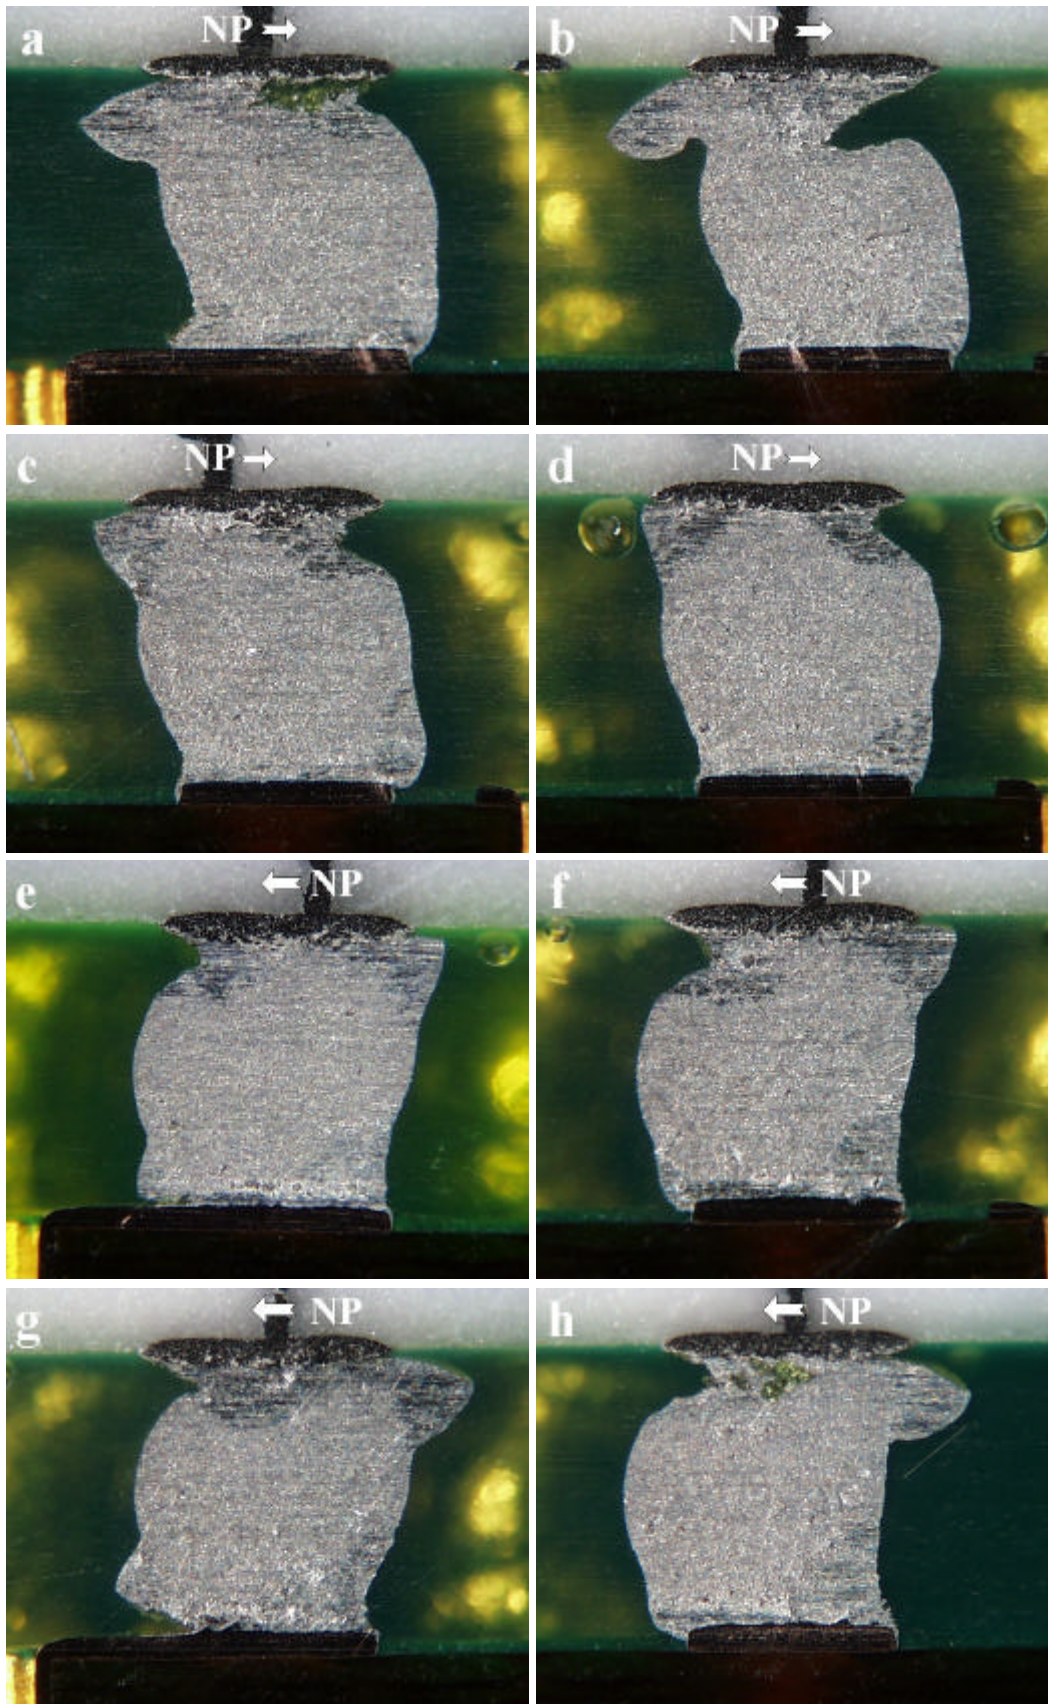
Figure 33. Cross-sections of solder joints to a CBGA soldered with the high peak temperature and exposed to 500 thermal cycles. Views are taken at Positions A2 (a), B3 (b), D5 (c), F7 (d), AA22 (e), AB23 (f), AC24 (g), and AD25 (h)

Cross-sections of thermally cycled solder joints to CBGAs mounted on assemblies soldered using high peak temperature and vapour phase soldering are shown in Figures 33 and 34, respectively. The appearances of the cross-sectioned solder joints to the CBGA mounted on the assembly soldered using the high peak temperature are very similar to the solder joints to the CBGA that had been soldered using a low peak temperature (Figures 27 and 28). However, there is one difference: the deformation and cracking of the solder between the balls and board pads with inward connections to vias were much less for the CBGA soldered using the high peak temperature. Still, there was no cracking in the laminate beneath these solder pads (Figure 35). The decreased cracking between solder balls and board solder pads resulted in very few solder balls remaining on the package, when analysed using the dye-penetrant method (Figure 37a).

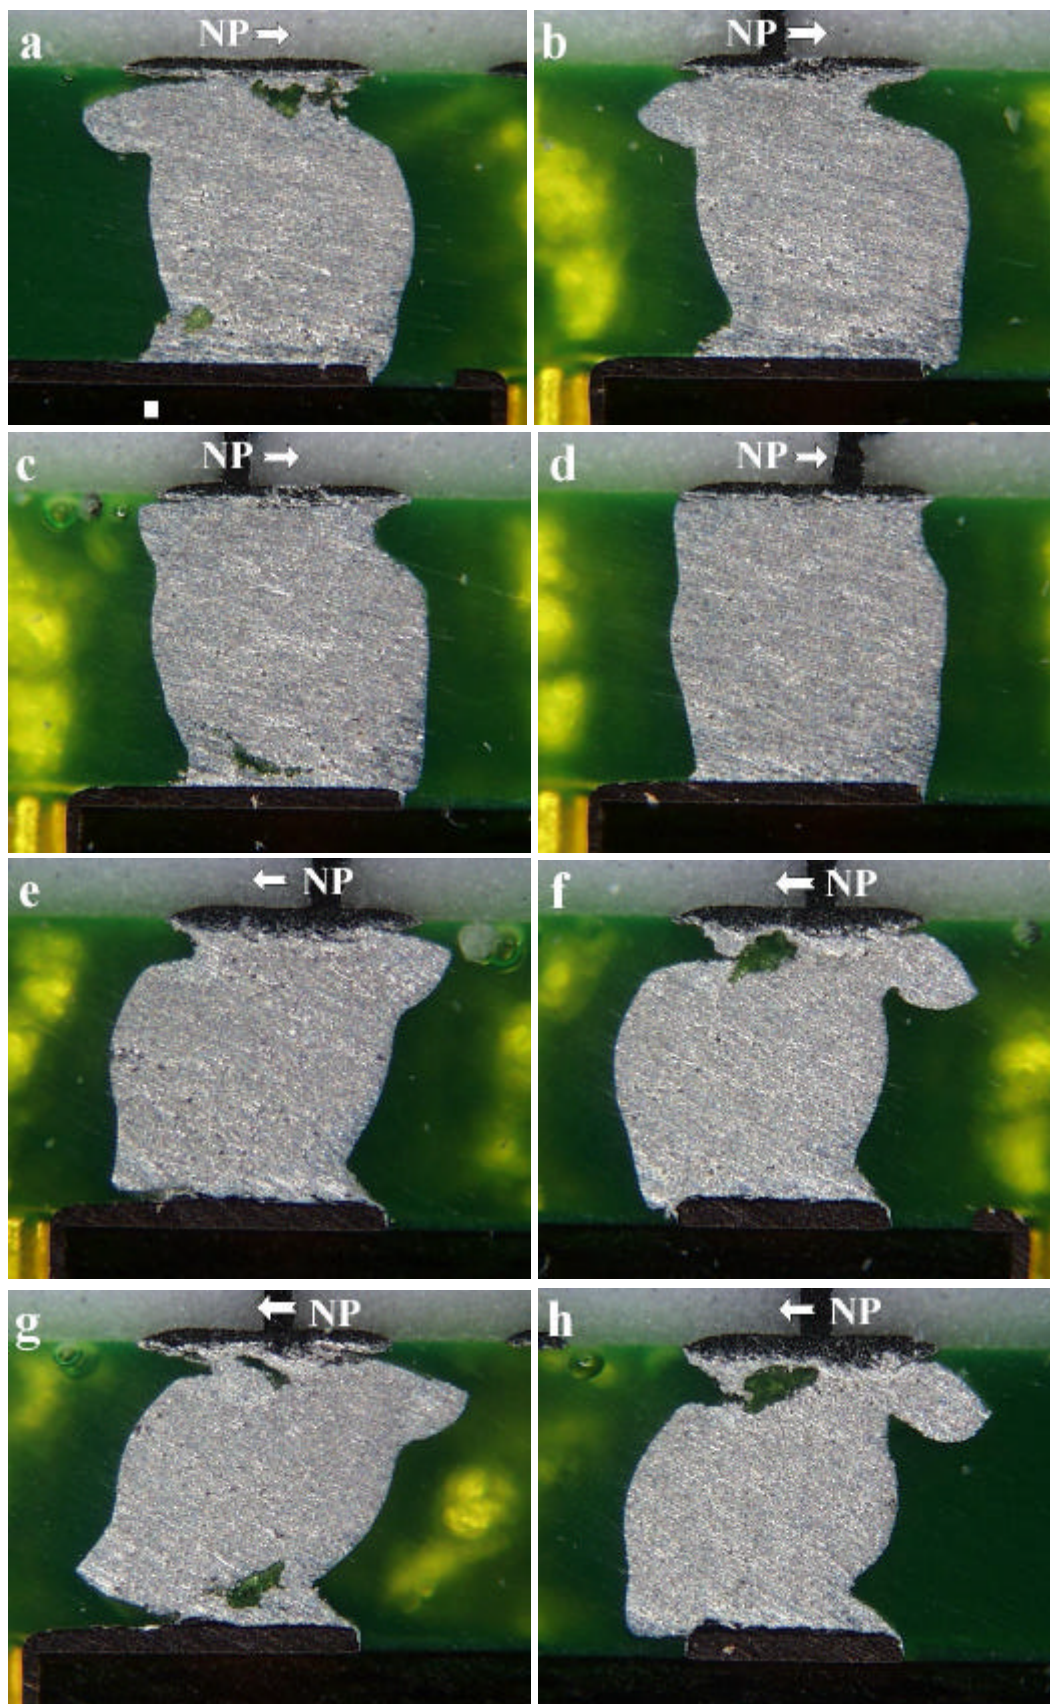
Figure 34. Cross-sections of joints to a CBGA soldered with vapour-phase soldering and exposed to vibration exposure and 500 thermal cycles. Views are taken at Positions A1 (a), D4 (b), F6 (c), H8 (d), AB22 (e), AC23 (f), AD24 (g), and AE25 (h)

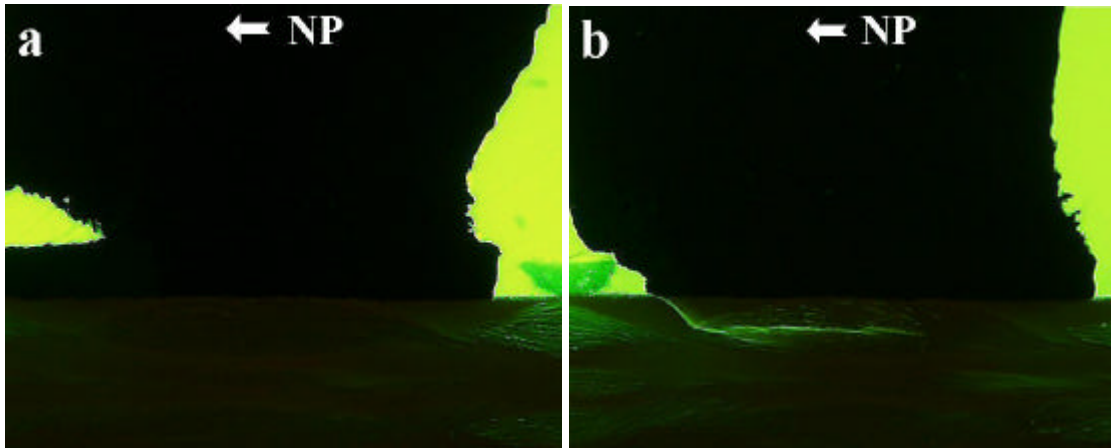
Figure 35. Cracks in the laminate beneath the solder pads to a CBGA soldered with the high peak temperature and exposed to 500 thermal cycles. Views are taken at Positions AC24 (a) and AD25 (b)

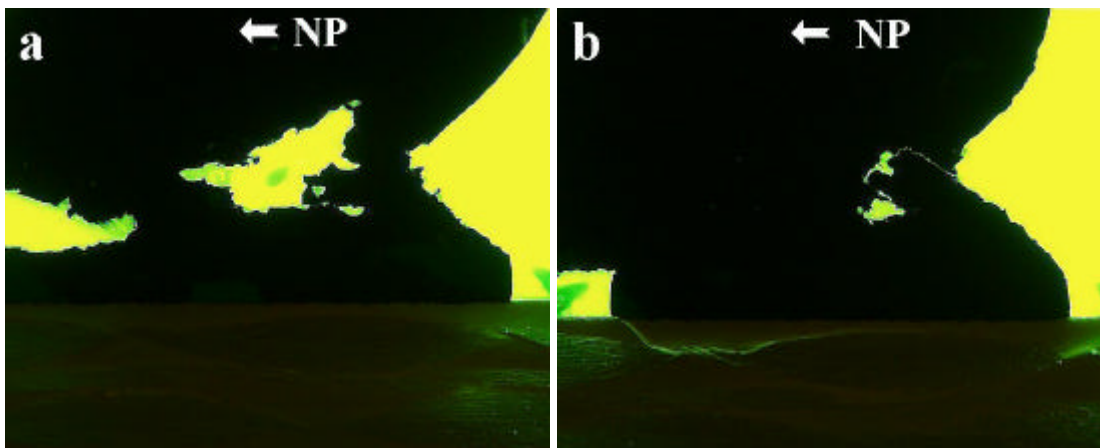
Figure 36. Cracks in the laminate beneath the solder pads to a CBGA soldered with vapour phase soldering and exposed to 500 thermal cycles. Views are taken at Positions AI AD24 (a) and AE25 (b)

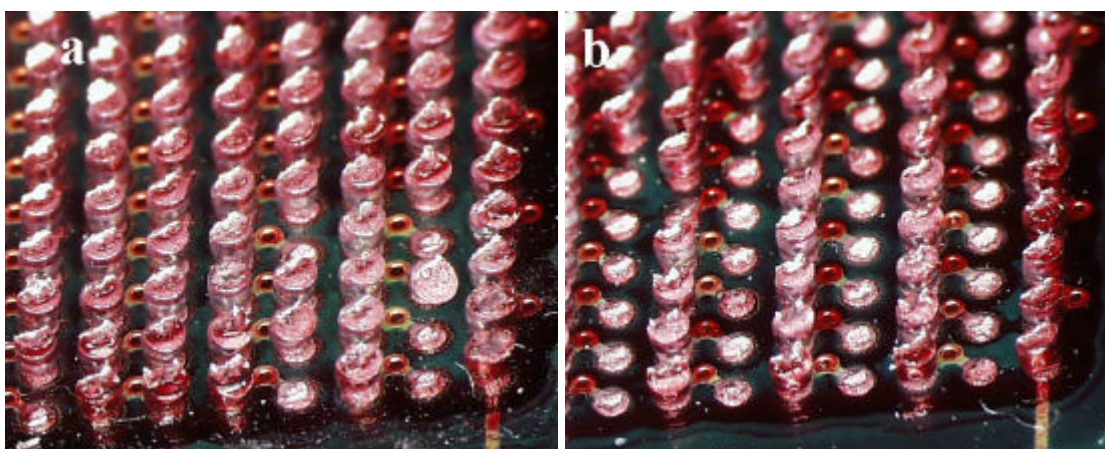
Figure 37. Board views showing locations of cracks in the solder joints after 1000 cycles analysed using a dye penetrant for CBGAs soldered with high peak temperature (a) and vapour phase soldering (b)

Consequently, increased deformation and cracking of the solder between solder balls and board solder pads with inward connections to vias could be expected for the vapour-phase soldered assemblies. Since the deformation and cracking in this case are very severe after 500 cycles, it is difficult to tell if that is the case, but a sample analysed with dye-penetrant indicates that it is. Somewhat more solder balls, from board solder pads with inward connection to vias, remained on the package when it was removed (compare Figure 37b with Figure 29a).

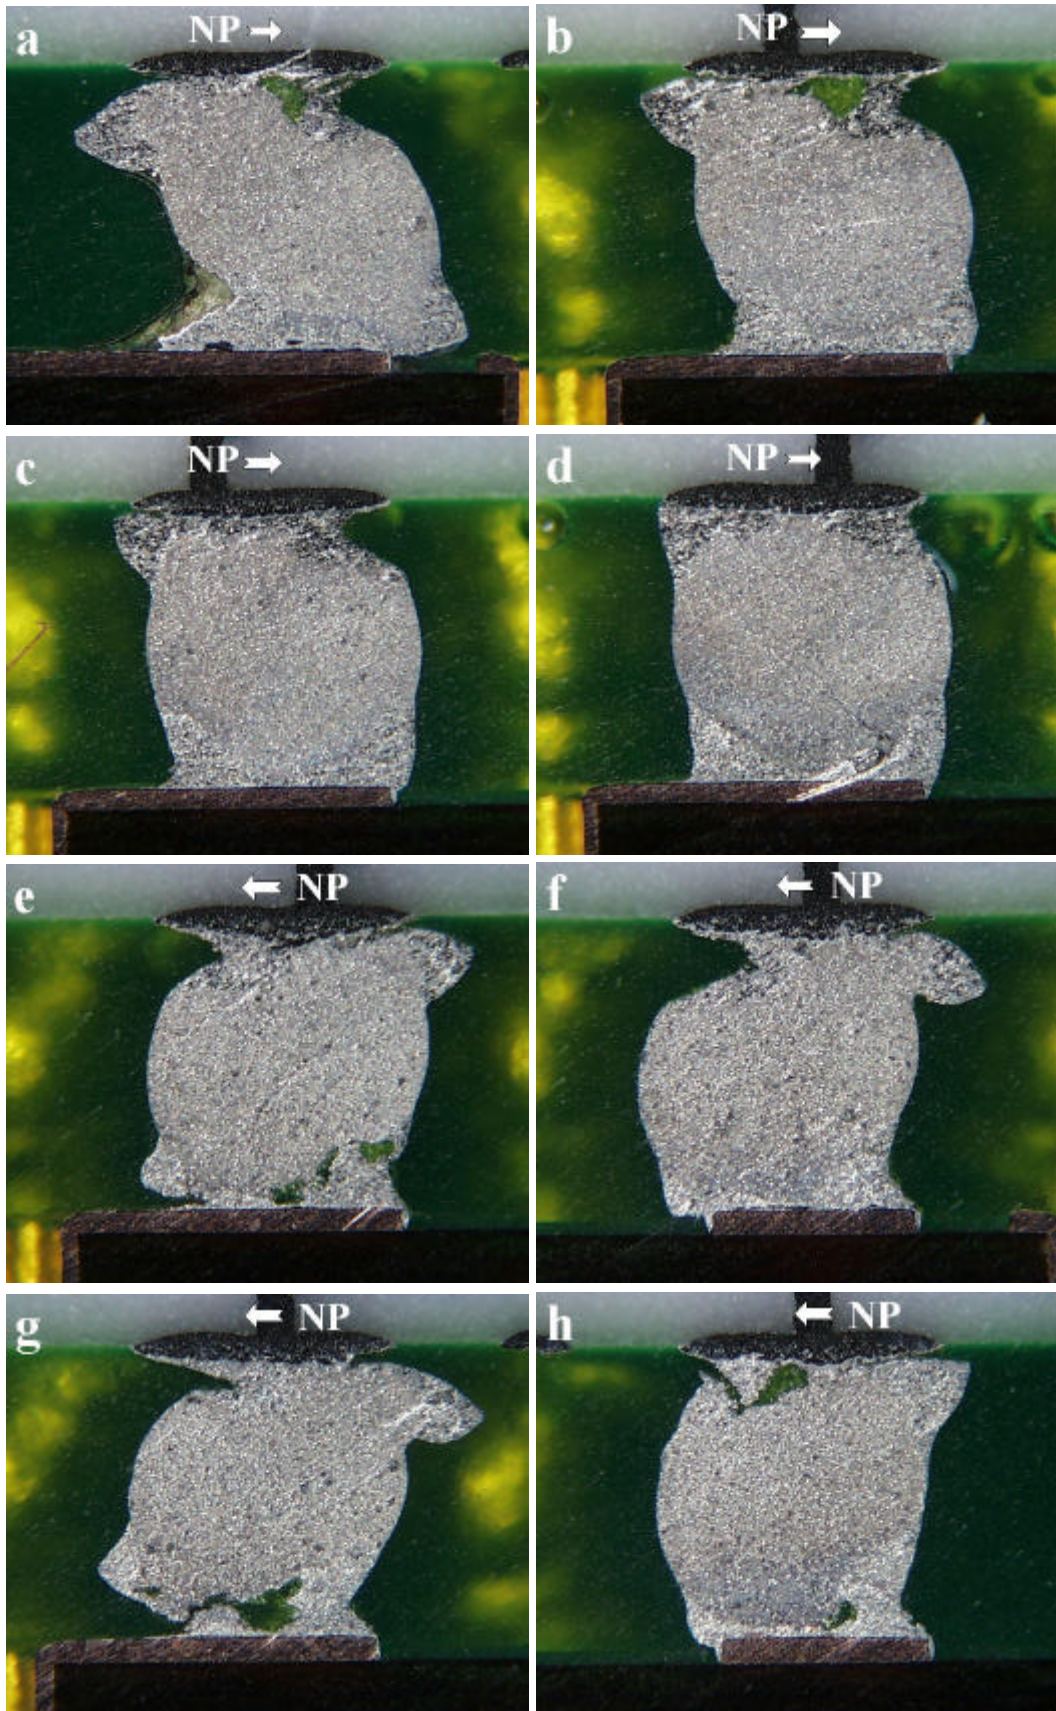
Figure 38. Cross-sections of solder joints to a CBGA soldered to a moisture-soaked printed board and exposed to 500 thermal cycles. Views are taken at Positions A1 (a), D4 (b), F6 (c), H8 (d), AB22 (e), AC23 (f), AD24 (g), and AE25 (h)

Solder joints to CBGAs soldered to moisture-soaked printed boards showed deformation and cracking (Figures 38 and 39) that were similar to what was observed for those soldered to dried boards using the low peak temperature (Figures 27 and 28). Maybe the deformation of the solder joints was slightly less pronounced near the package side of the joints on the moisture-soaked boards. No significant difference in laminate cracking could be observed that might explain the improved fatigue life of the CBGAs soldered to the moisture-soaked boards. Nevertheless, comparatively few solder balls remained on the package when a CBGA that failed after 837 cycles was analysed using a dye penetrant (Figure 40), indicating that the integrity of the board laminate has been affected by the high humidity level during soldering.

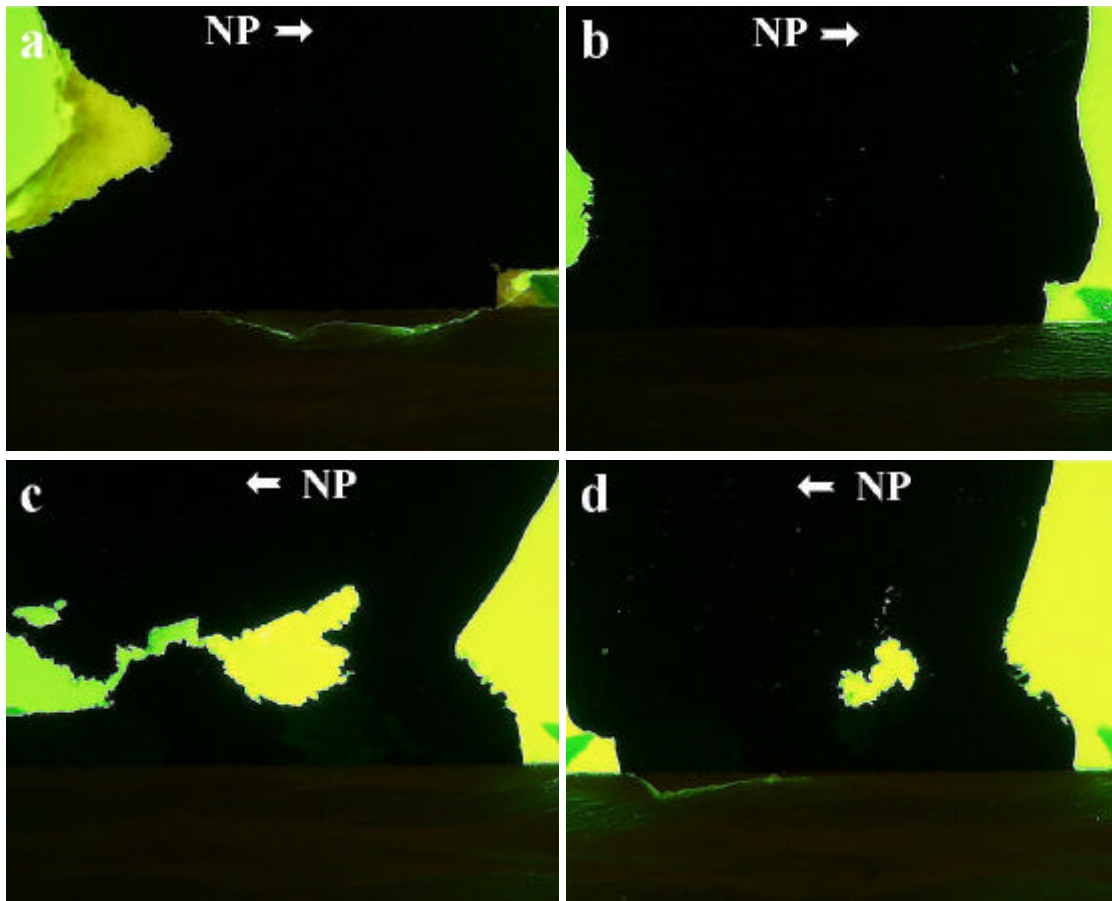
Figure 39. Cracks in the laminate beneath the solder pads to a CBGA soldered to a moisture-soaked printed board that has been exposed to 500 thermal cycles. Views are taken at Positions A1 (a), D4 (b), AD24 (c), and AE25 (d)

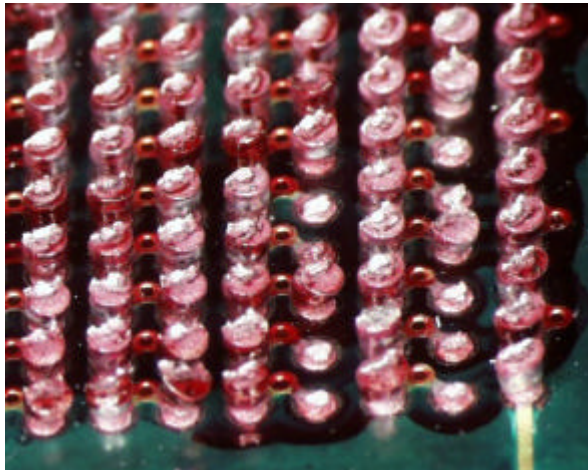
Figure 40. Board views showing locations of cracks in the solder joints after 1000 cycles, analysed using a dye penetrant for a CBGA soldered to a moisture-soaked board (first failure after 837 cycles)

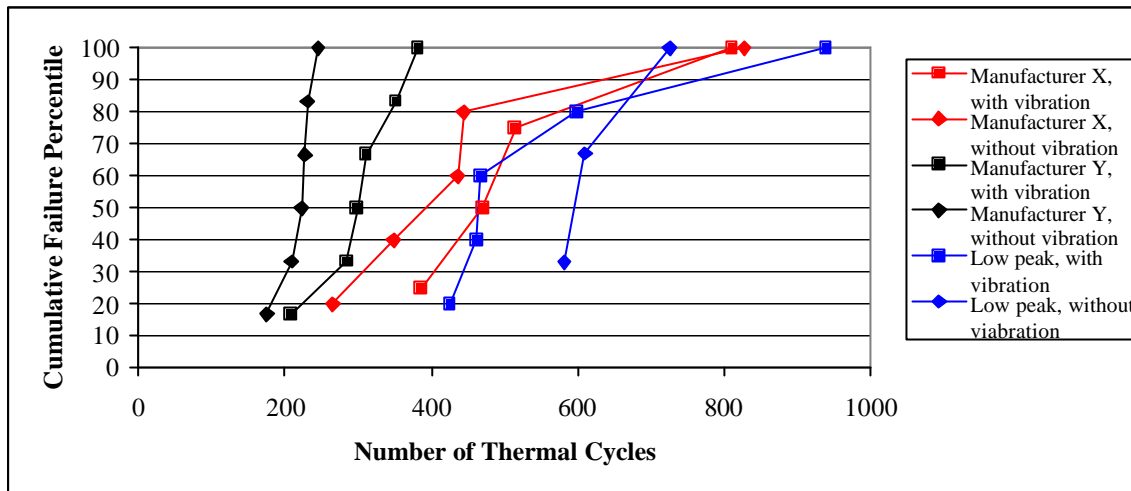
Figure 41. Cumulative cycles-to-failure of CBGAs mounted on boards with via-in-pad design. The results for CBGAs mounted on boards with dogbone design, soldered with low peak temperature, are given as reference

fatigue life decreased with about 30% and 65%, respectively, compared to assemblies with dogbone design.

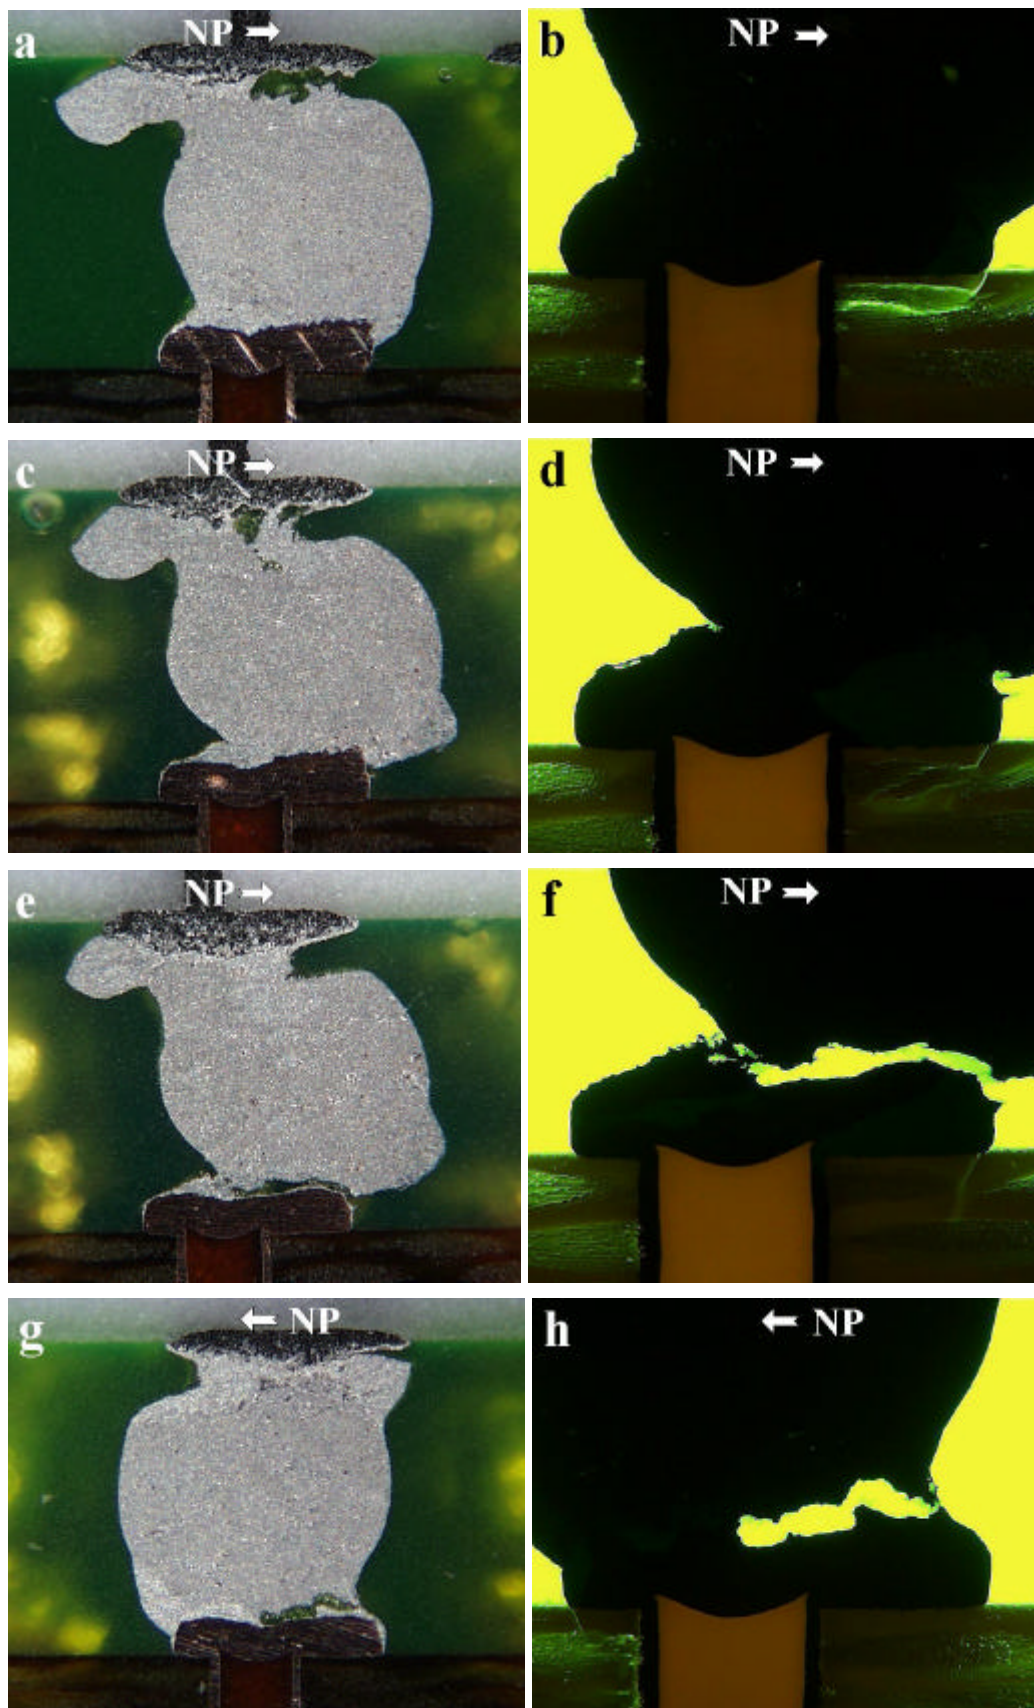
Figure 42. Cross-sections of solder joints to a CBGA soldered on a printed board with via-in-pad design produced by Manufacturer X and exposed to 500 cycles. Open circuit was registered after 265 cycles. The views show solder joints at Positions AE25 (a and b), AC23 (c and d), AB22 (e and f), and G7 (g and h)

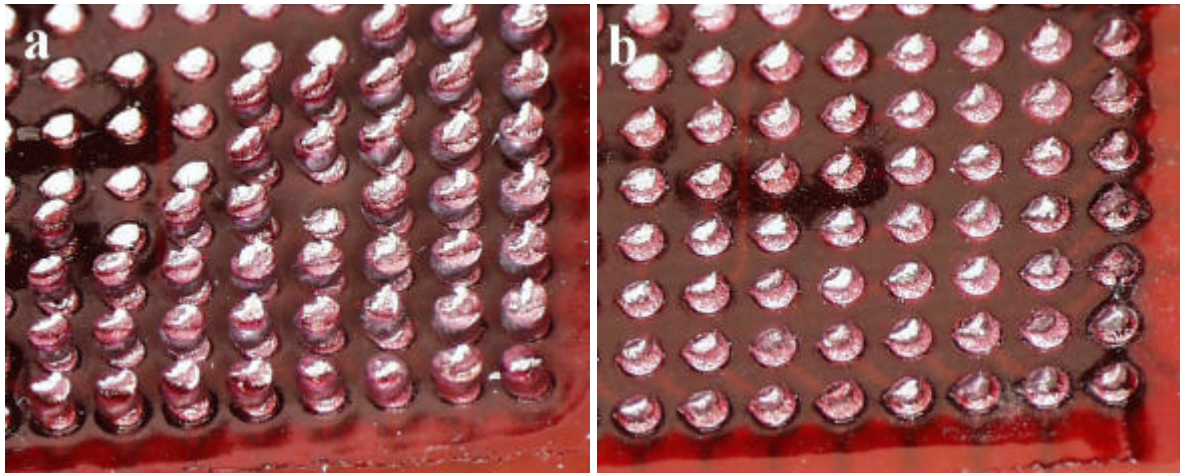
*Figure 43. Board views showing locations of cracks in the solder joints after 500 cycles analysed using a dye penetrant for CBGAs that have been mounted on printed boards from Manufacturer X (a) and Y (b)*

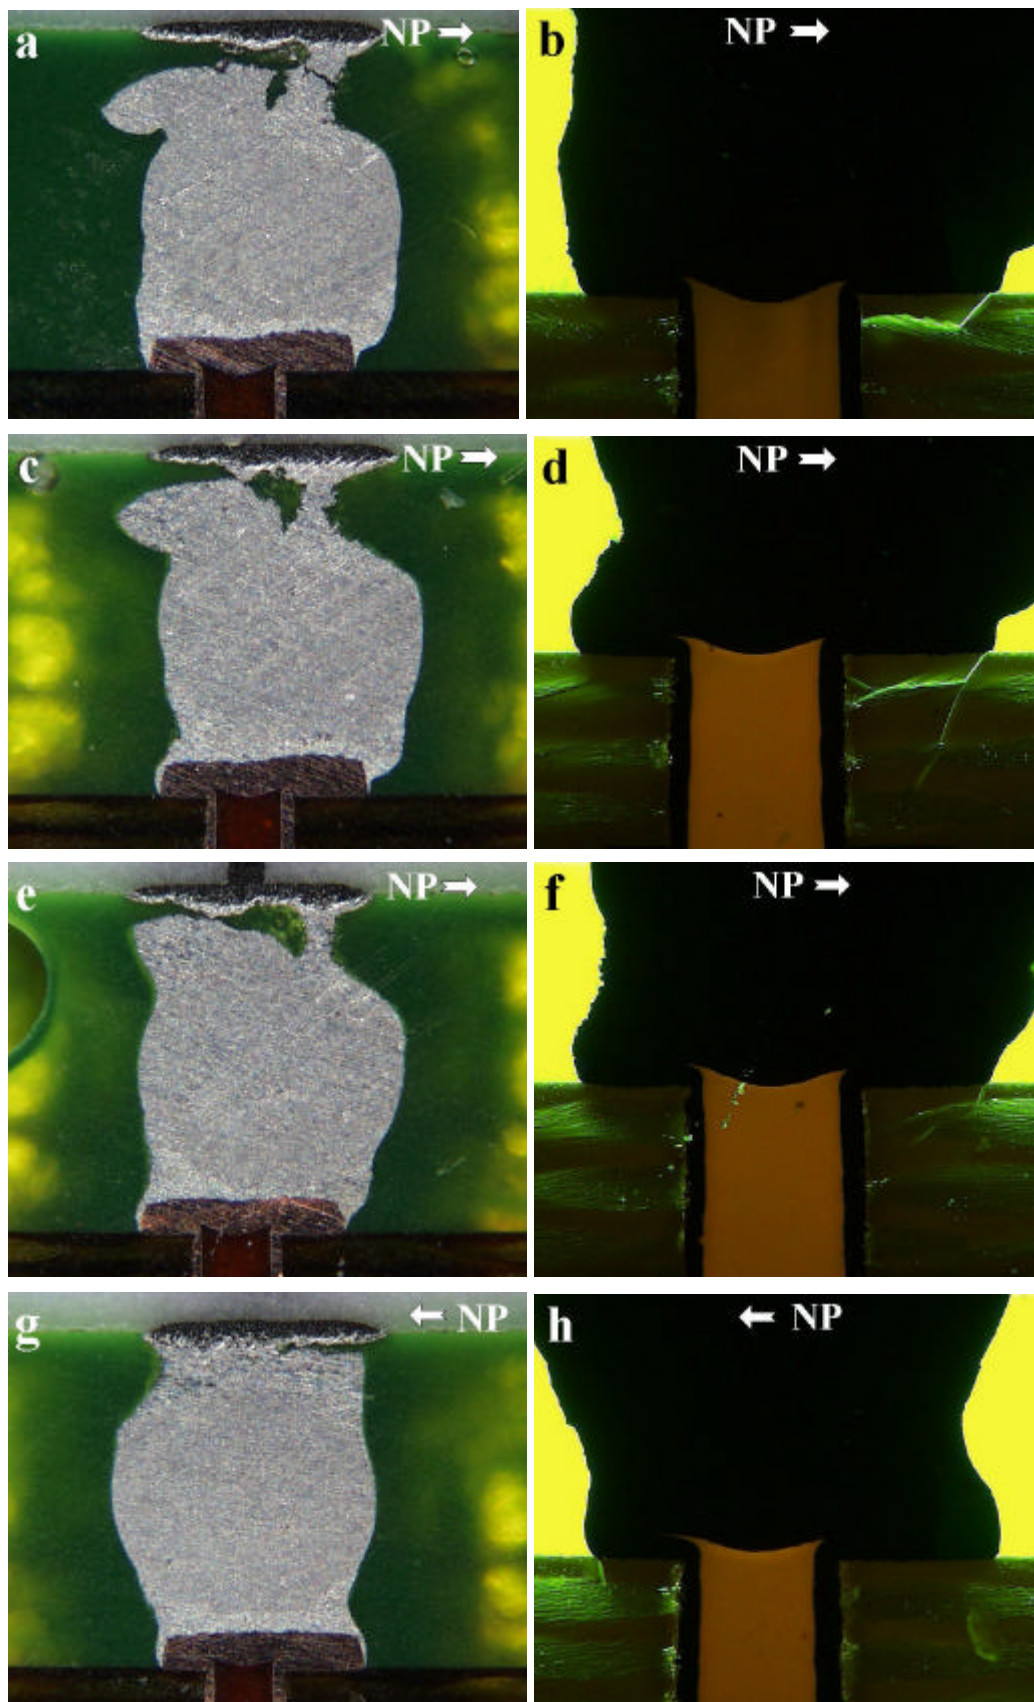
Figure 44. Cross-sections of solder joints to a CBGA soldered on a printed board with via-in-pad design produced by Manufacturer X and exposed to 1000 cycles. Open circuit was registered after 827 cycles. The views show solder joints at Positions A1 (a and b), D4 (c and d), G7 (e and f), and T16 (g and h)

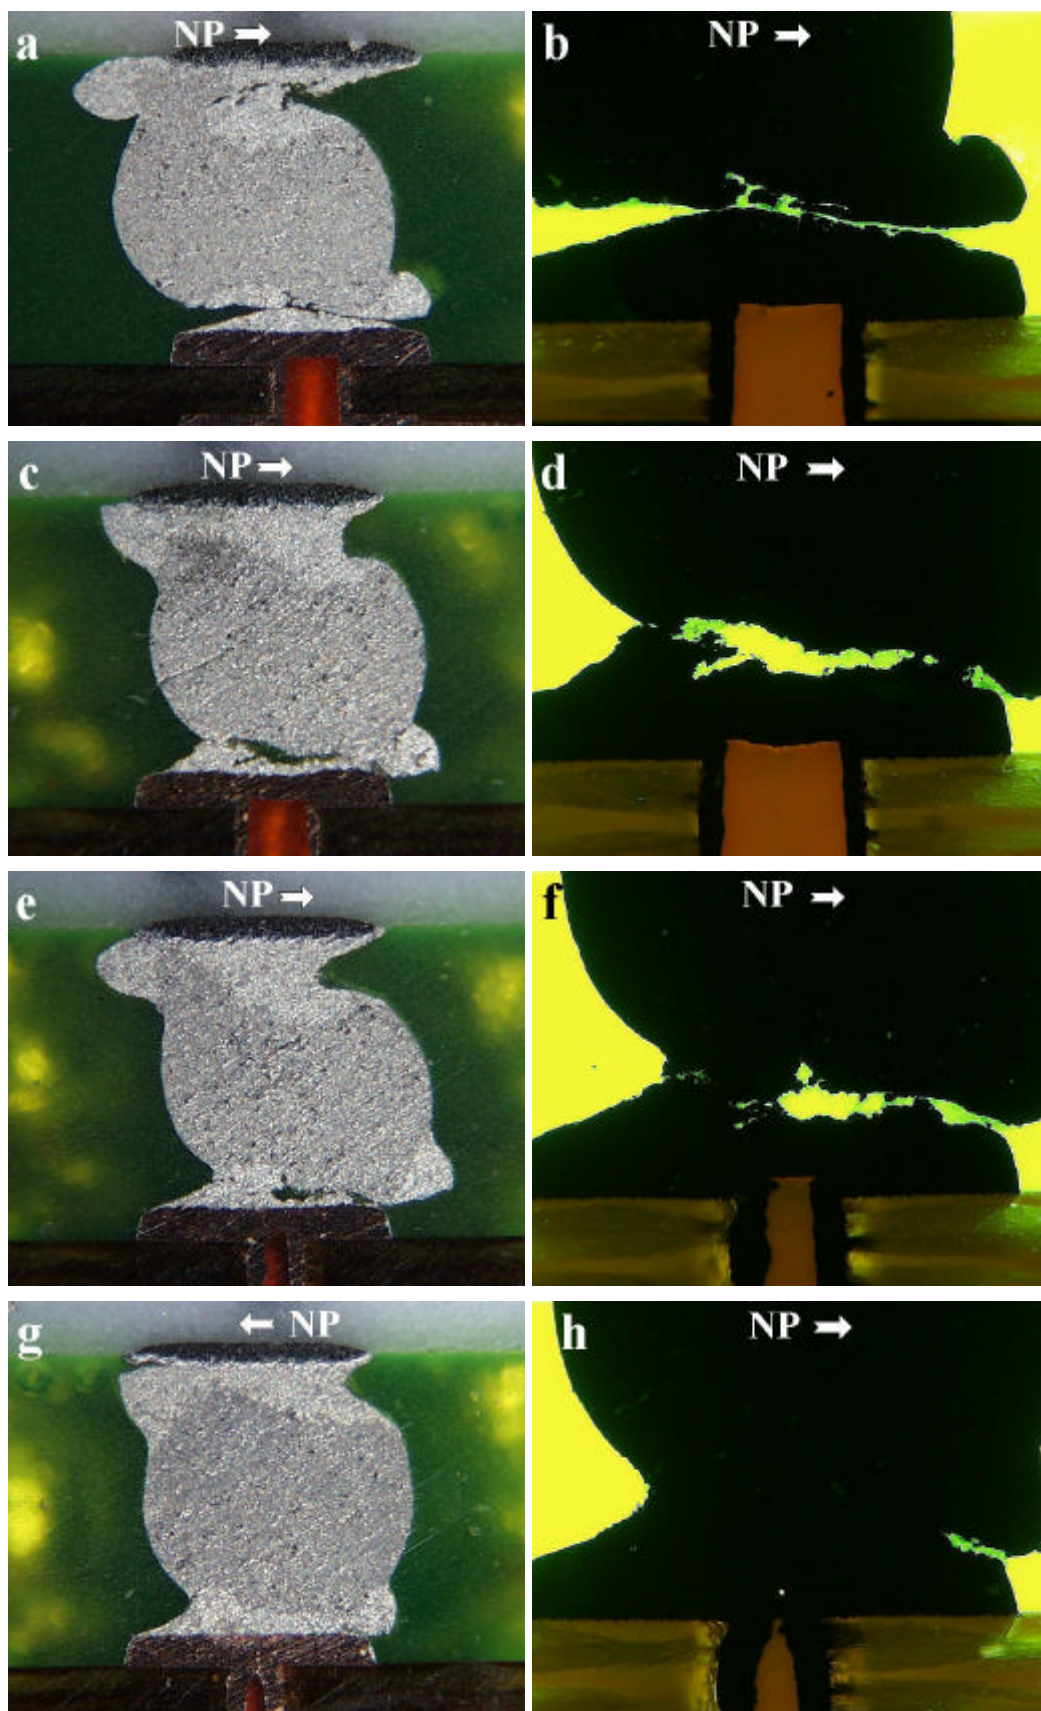
Figure 45. Cross-sections of solder joints to a CBGA soldered on a printed board with via-in-pad design produced by Manufacturer Y and exposed to 500 cycles. The views show solder joints at Positions AE25 (a and b), AC23 (c and d), AA21 (e and f), and W19 (g and h)

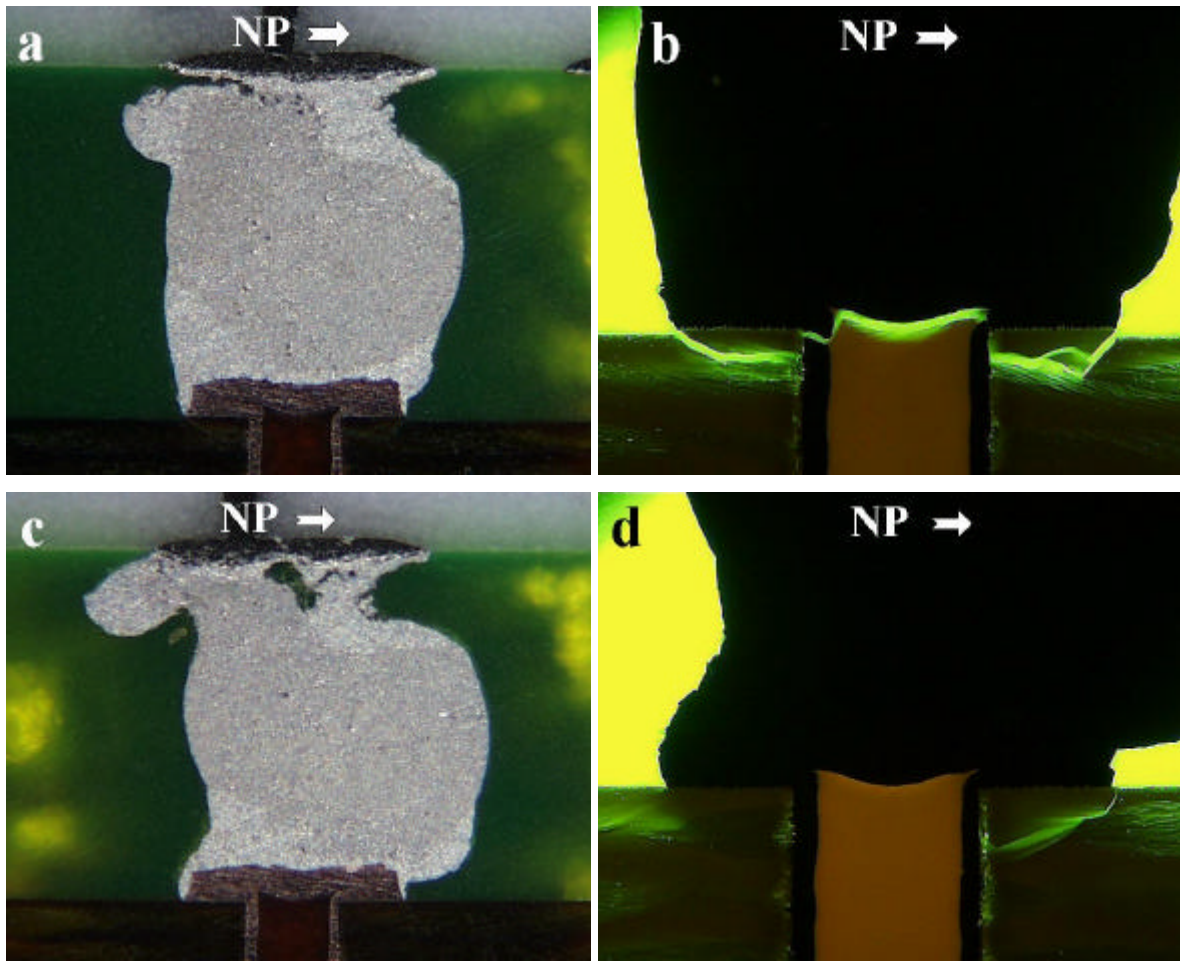
Figure 46. Cross-sections of joints to a CBGA soldered on a printed board with via-in-pad design produced by Manufacturer X and exposed to 500 cycles and vibration. The views show solder joints at Positions AE1 (a and b) and AB4 (c and d)

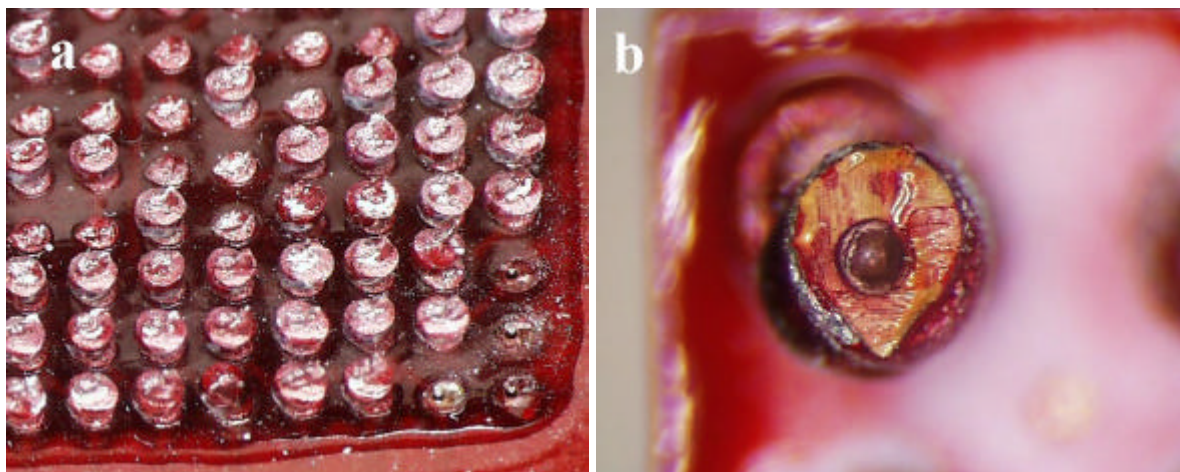
Figure 47. To the left, a view showing ripped-off copper pads to four corner solder-joints for a CBGA that has been mounted on a printed board from Manufacturer X and exposed to 1000 cycles and vibration. The underside of the ripped-off corner joint is shown to the right

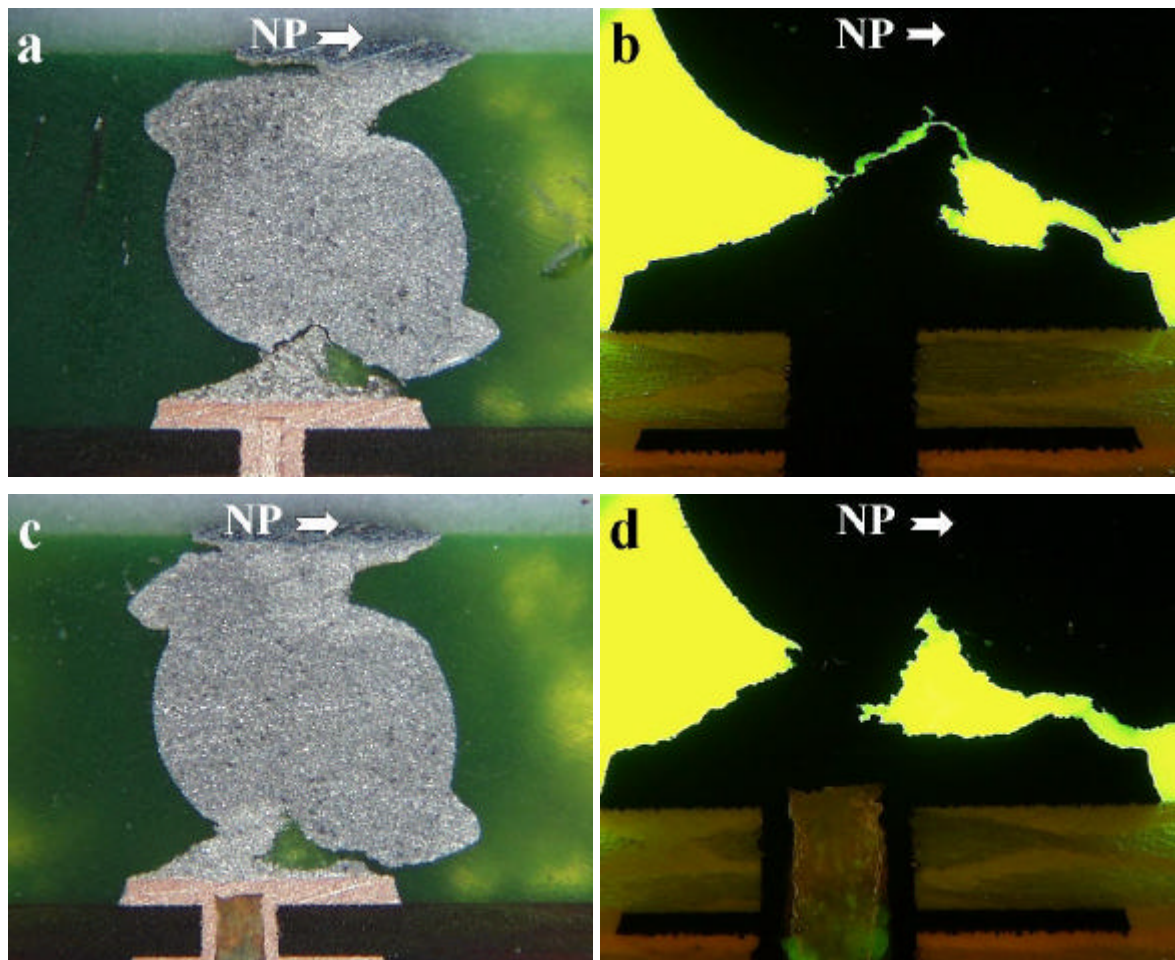
Figure 48. Cross-sections of solder joints to a CBGA on a printed board with via-in-pad design produced by Manufacturer Y and exposed to 500 cycles and vibration. The views show solder joints at Positions A2 (a and b) and D5 (c and d)

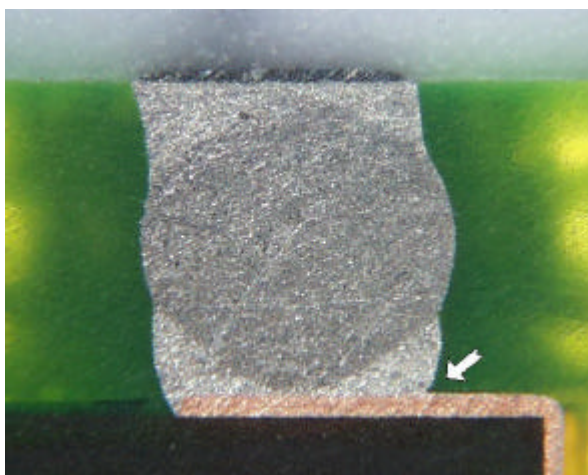
*Figure 49. View showing point of stress concentration for a solder joint with inward connection to a via. The solder pad is solder-mask defined at this point*

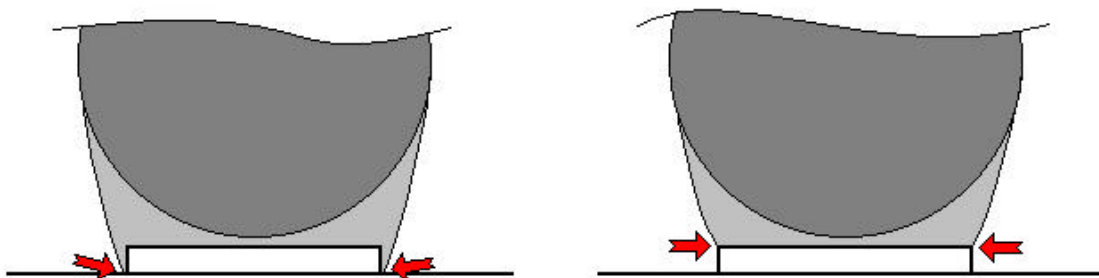
*Figure 50. Geometries for solder joint fillets between solder balls and boards pads with good (left) and poor (right) wetting of solder pad edges. The arrows show the points of highest stress during thermal cycling*

Optimisation of the geometry of the solder joint fillet between board pads and the high-melt balls is important for achieving long fatigue life. The fillet needs to have a convex surface with good wetting of solder pad edges for best result.
